R22 & R44 SAFETY ALERT

Issued: 04 January 2007 Revised: 22 March 2007

MAIN ROTOR BLADE SKIN DEBONDING

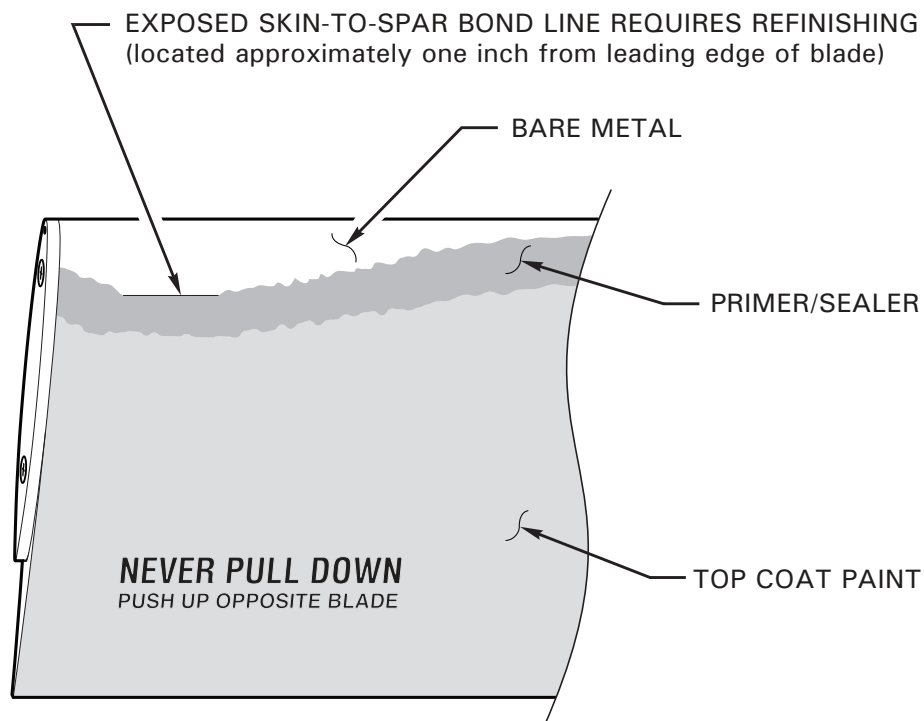
MAIN ROTOR BLADE LOWER SURFACE

RHC has received additional recent reports of main rotor blade skins beginning to debond (separate) at the skin-to-spar bond line on the lower surface near the blade tip. Debonding can occur when the leading edge of the skin is exposed due to erosion of the blade finish at the bond line (seam between leading edge of the skin and spar).

See figure below. During each daily preflight, visually check blade finish along lower surface bond line. If any bare metal is exposed at or beyond bond line, have blade refinished per R22 Service Letter SL-56 or R44 Service Letter SL-32 by a qualified mechanic before further flight.
