**R22 SERVICE LETTER SL-56**

**R44 SERVICE LETTER SL-32**

**DATE:** 16 March 2007    **REVISION A:** 29 March 2007

**SUBJECT:** Main Rotor Blade Bond Inspection and Maintenance

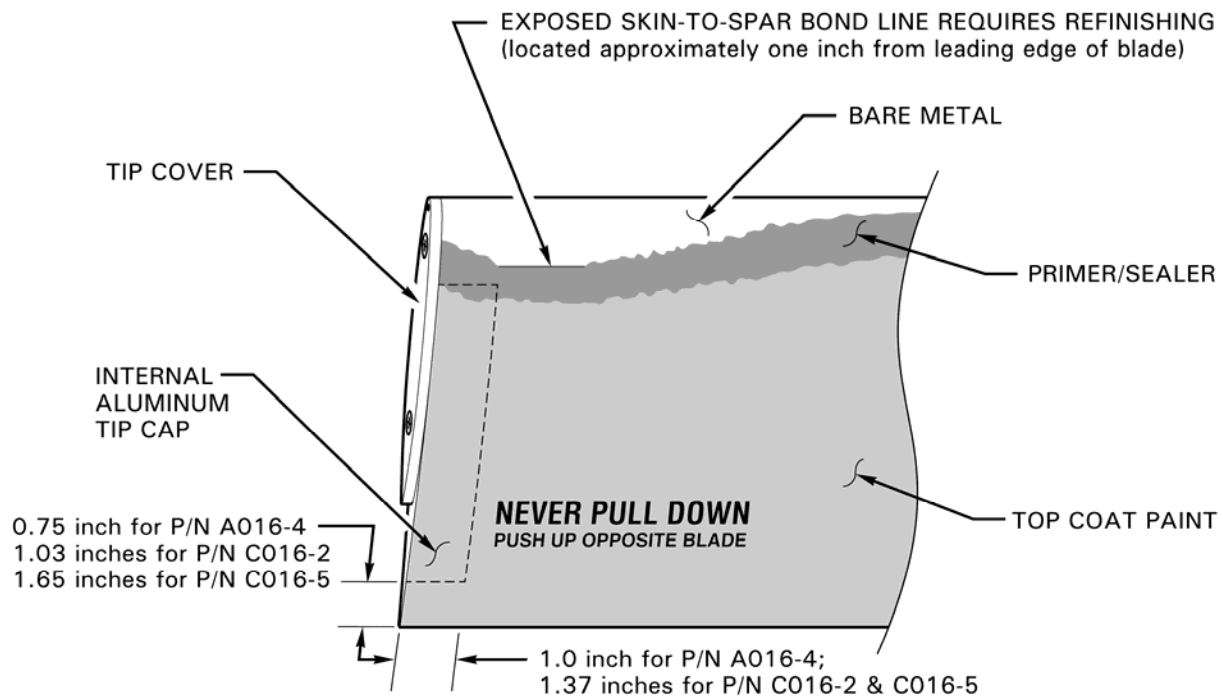
MAIN ROTOR BLADE LOWER SURFACE

**BACKGROUND:** Debonding of rotor blade skins can occur when the bond line is exposed due to erosion of the blade finish or when corrosion occurs on the internal aluminum tip cap. Proper inspection and protection of bonded areas is required.

1. Remove both main rotor blade tip covers. Using 10x magnification, visually inspect blade tip area inside covers. Tap test skin-to-tip cap bond joints on both upper and lower surfaces. If visual indications of corrosion or separation or any voids are detected, blade is unairworthy.
2. Using 10x magnification, visually inspect leading edge of any exposed (bare metal) blade skin at skin-to-spar bond line. Tap test all exposed skin-to-spar bonded areas. If any visual indications of separation or any voids are detected, blade is unairworthy.
3. Feather edge of paint bordering bare metal by hand-sanding spanwise with 220-grit or finer wet-or-dry aluminum-oxide or silicon-carbide abrasive paper. Do not remove metal.

4. Mask area to prevent overspray contamination.
5. Clean bare metal to be painted with a lint-free cloth dampened with enamel cleaner.
6. Prime bare metal with at least two coats of epoxy primer. Scuff primer prior to applying new coat.

7. Apply flat black Dupont Imron 373-P-29950 and/or yellow Imron K0680HK polyurethane enamel (or equivalent) to primed area in accordance with paint manufacturer's recommendations. Dupont recommendations are available online at:

8. Install blade tip covers.
9. Make appropriate maintenance record entries.
