R66 SERVICE BULLETIN SB-14

DATE: 25 June 2015

SUBJECT: Tail Rotor Drive Shaft Forward Bearing

ROTORCRAFT AFFECTED: R66 Helicopters S/N 0003 thru 0630 except S/N 0522, 0542, 0543, 0575, 0587, 0590, 0592, 0595, 0596, 0597, 0602, 0603, 0604, 0605, 0607, 0608, 0609, 0614, 0616, 0617, 0618, 0626, 0627, and 0629.

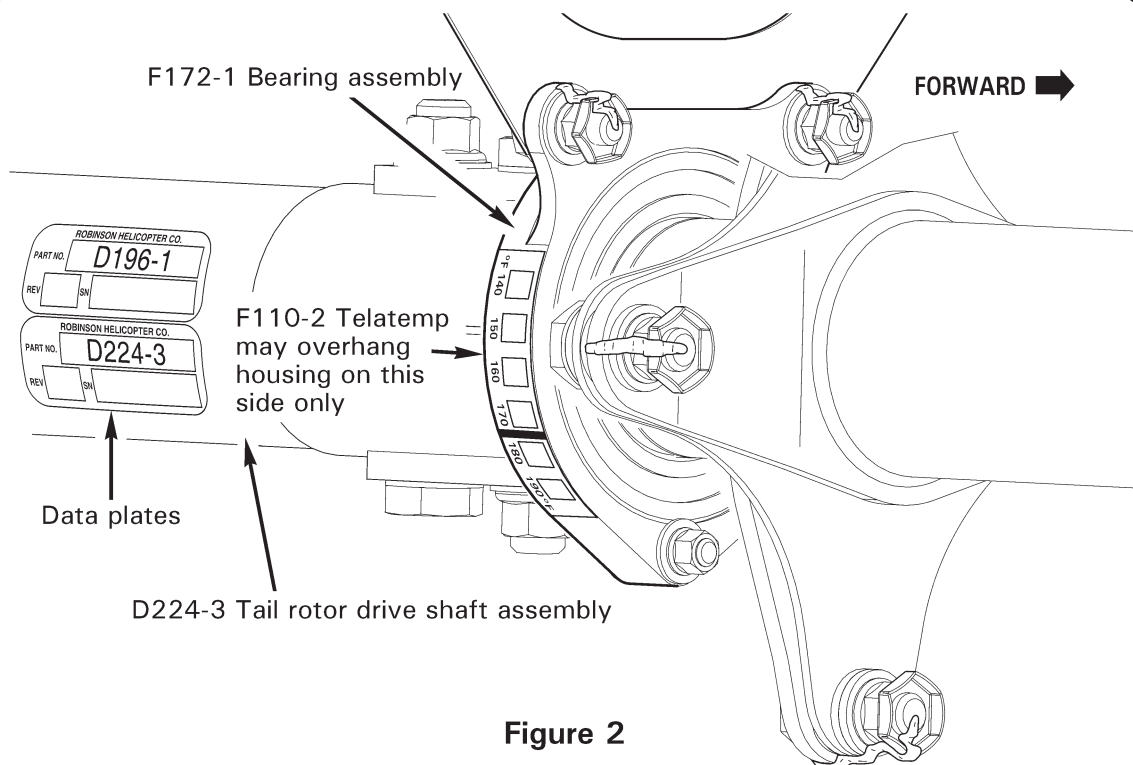
Figure 2

BACKGROUND: RHC has received reports of overheating F172-1 bearing assemblies (installed on the D224-3 tail rotor drive shaft assembly's forward yoke). This bulletin requires installing a Telatemp temperature recorder on the F172-1 bearing assembly and inspecting the Telatemp during preflight checks and during each 100-hour inspection. If the Telatemp shows that the bearing is running hot, a kit is available to upgrade the bearing to a newer design.

1. Refer to Figure 1. Using a black, permanent-ink marker, draw a line between the 170°F and 180°F temperature squares on a P/N F110-2 or 110-2 Telatemp. Trim Telatemp as shown; ensure the Fahrenheit temperature scale is still legible.
2. Remove tailcone cowling per R66 Maintenance Manual (MM) § 53-23.
3. Refer to Figure 2. Using a lint-free cloth dampened with acetone, clean exterior of F172-1 bearing assembly. Install trimmed Telatemp on right side of F172-1 bearing assembly as shown. Ensure squares are well bonded to the bearing housing. Allow the temperature scale to overhang the aft edge of the housing if necessary. Install tailcone cowling per MM § 53-23.
4. Insert enclosed Special Pilot Caution (page 3 of this bulletin) as the first sheet of the Pilot's Operating Handbook.

1. Inspect Telatemp on F172-1 bearing assembly. If any squares have darkened beyond black line (180°F or greater), order one KI-235 kit and install per [kit instructions](#).
2. Make appropriate maintenance record entries.

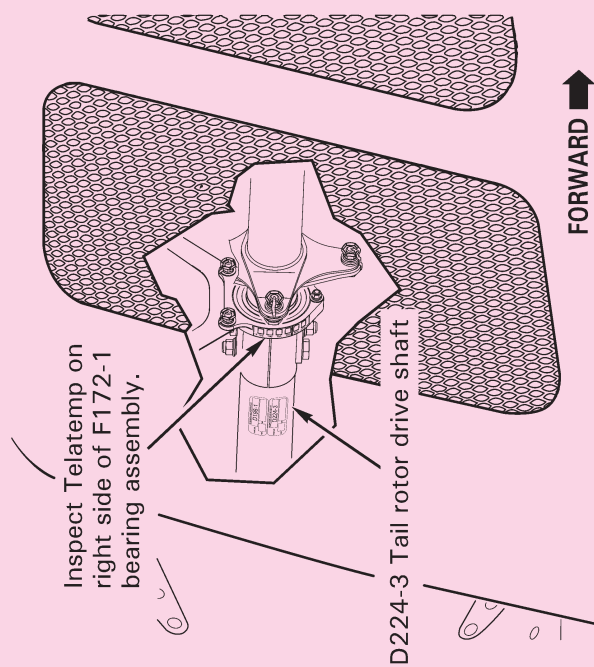
RHC has received reports of overheating F172-1 bearing assemblies.

During each preflight check, inspect Telatemp on right side of F172-1 bearing assembly. If any squares have darkened beyond black line (180°F or greater), have aircraft serviced prior to further flight.
