R44 SERVICE LETTER SL-69

R66 SERVICE LETTER SL-29

SUBJECT: C627-6 Five-point Harness Assembly Lower Strap

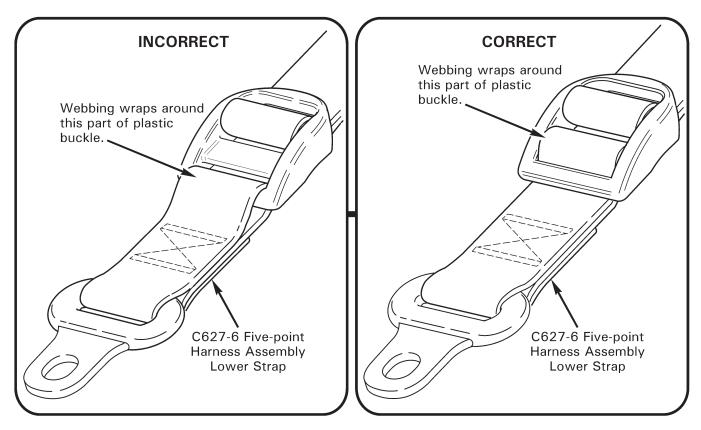
FIGURE 1

BACKGROUND: RHC has determined that the plastic adjusting buckle on the lower strap of C627-6 Five-point Harness Assemblies may have the webbing routed improperly. As a result, tightening the adjustment may crack the plastic buckle. Incorrect parts should be replaced to ensure that proper adjustment is available to the occupants.

- Refer to Figure 1. If lower strap of C627-6 Five-point Harness Assembly is assembled incorrectly, order one AmSafe p/n 5134-2010111747 Lower Strap from RHC Customer Service.
- 2. Refer to Figure 2. Remove incorrect lower strap and install correct lower strap using existing hardware as shown. Verify security.
