# Robinson Helicopter Company

### MANDATORY SERVICE BULLETIN SB-12

SUBJECT: Removal of sharp edges in the Angular Latch Portion of  
A628-1 and -2 Seat Harness Assembly.

ROTORCRAFT AFFECTED: R22 Serial Number 0002 thru 0153\*

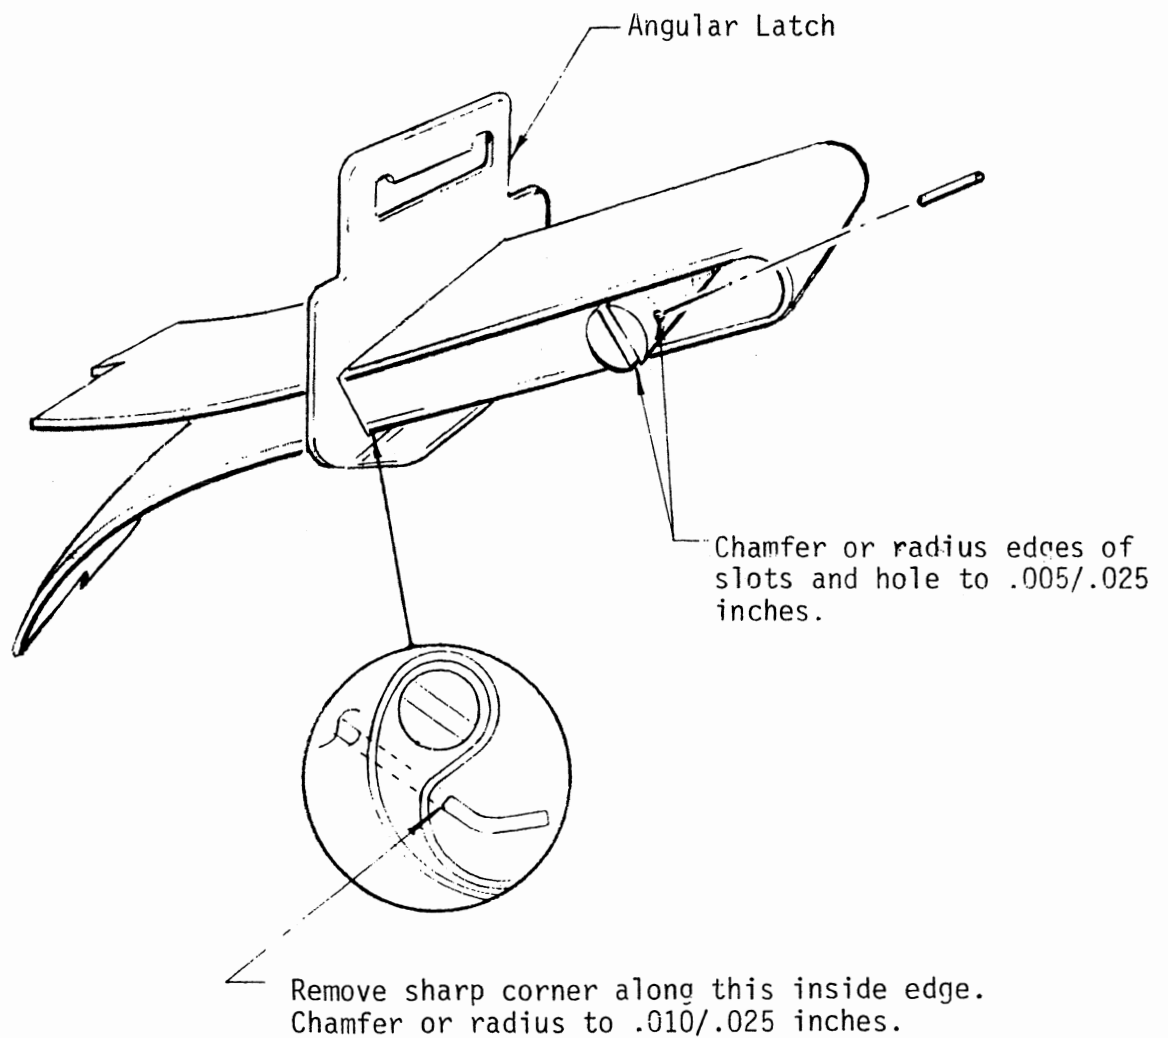
DIAGRAM OF ANGULAR LATCH

Some fraying of the webbing has been observed at the angular latch. In one incident, the webbing failed in an accident. The failure may have been related to a sharp edge on the round knurled locking bar or the latch plate.

1. Remove the locking bar by pressing the roll pin halfway out using a 3/32 dia. punch.
2. Chamfer or round edges of the slots and hole in the locking bar and also the inside edge of the latch plate as shown in the view on the attached sheet, using a file or hand grinder.
3. Reinstall the locking bar, pressing the roll pin flush with the surface.
