ROBINSON HELICOPTER COMPANY

SERVICE BULLETIN #23

Subject: Inspection of A020-2 Upper Steel Tube Frame

Rotorcraft Affected: All R22 helicopters S/N 0002 thru S/N 0311 having A020-2 Steel Tube Frames S/N 0002 thru S/N 0361 installed.

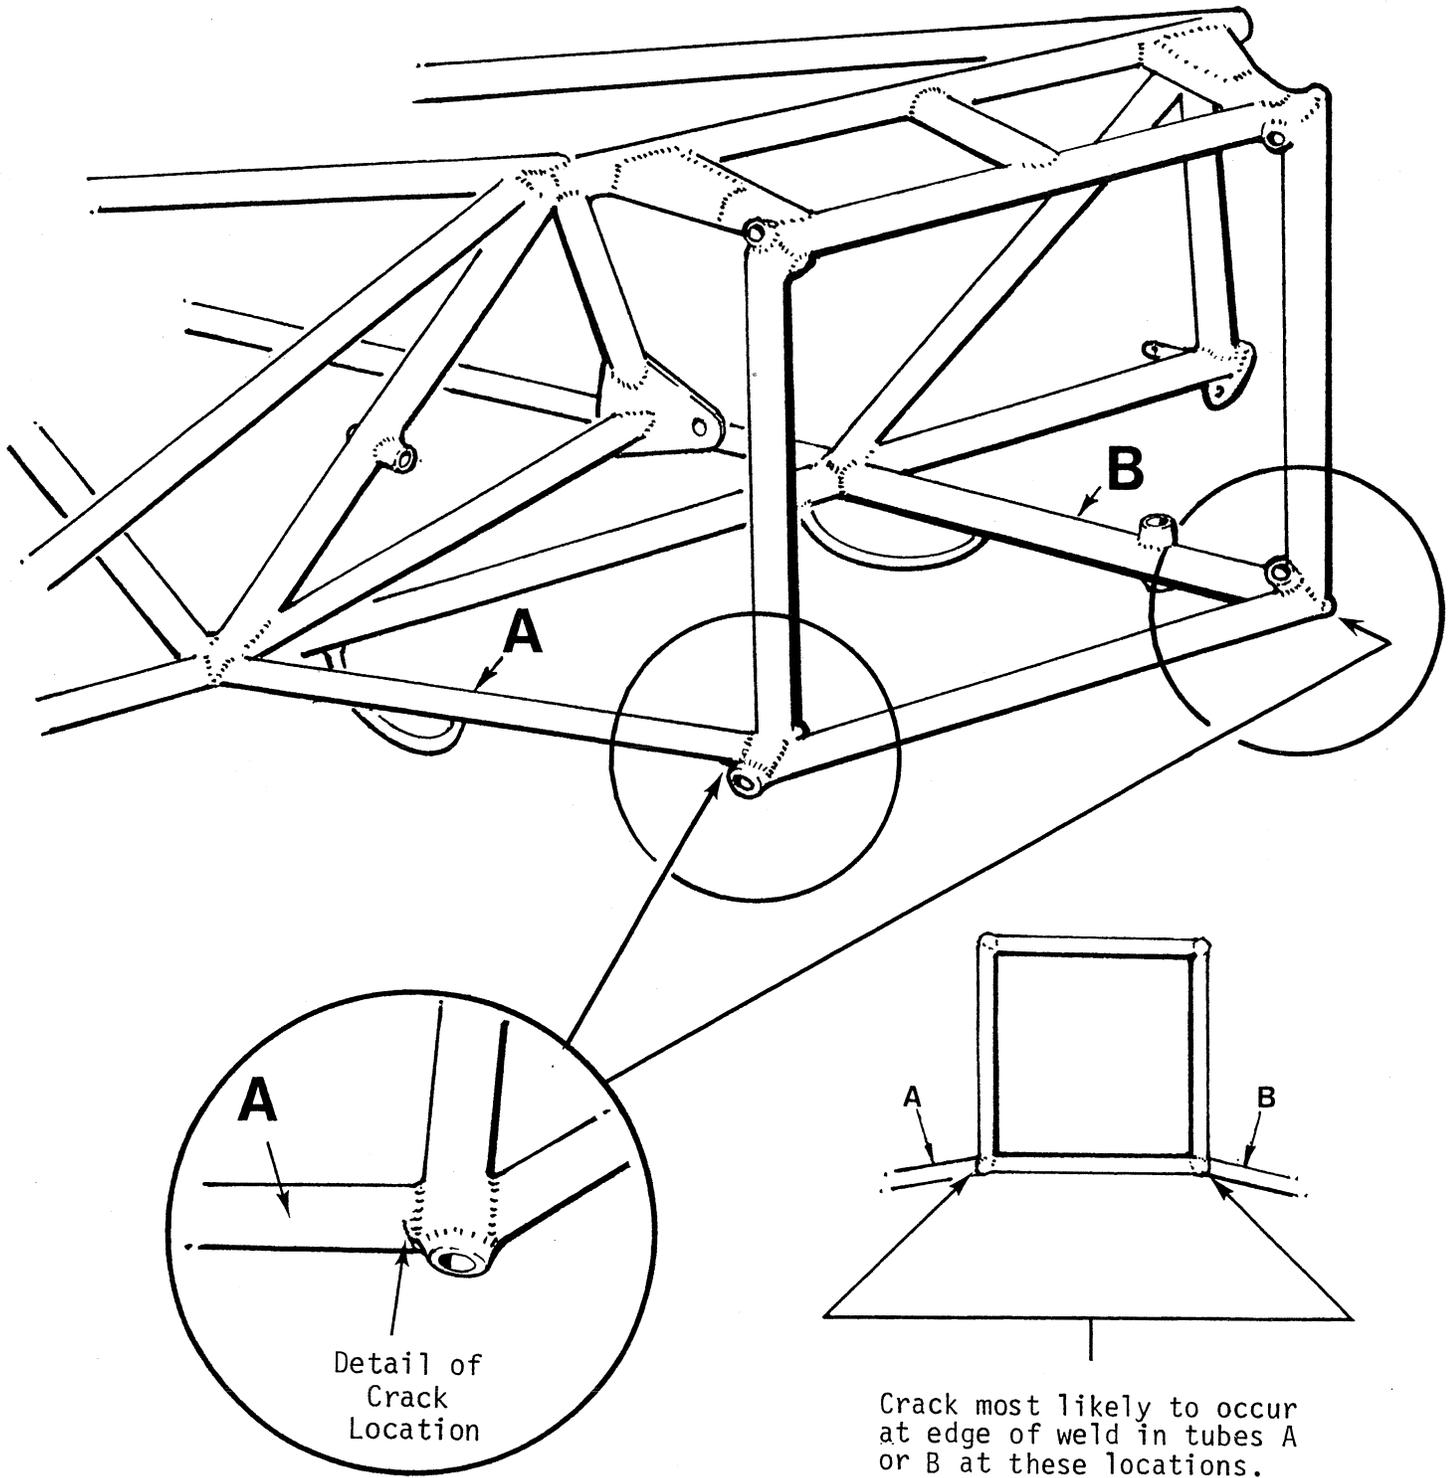
A020-2 Frame

Background: Fatigue cracks have been found at the locations shown in Figure 1. The cracks were detected by the pilot during his daily preflight inspection.

- 1) Using a dental mirror and a high intensity pen light, visually check the areas indicated in Figure 1. The check at the 50 hour interval between 100 hour inspections may be performed by a licensed pilot after he has received instructions from a licensed mechanic.
- 2) Make a logbook entry after every 50 hour visual check or inspection. The mechanic or pilot must verify that the inspection was performed by entering his name and Airman's certificate number.
- 3) Pilots should also include a visual check of this area in their daily preflight check. The inspection light and dental mirror is not required for the daily preflight check.
- 4) If a crack is found, remove the Steel Tube Frame from service and contact:
