SERVICE BULLETIN #37A

SUBJECT: Washer installed at M.R. Pitch Rod End

ROTORCRAFT AFFECTED: R22 Serial No. 0002 through 0333

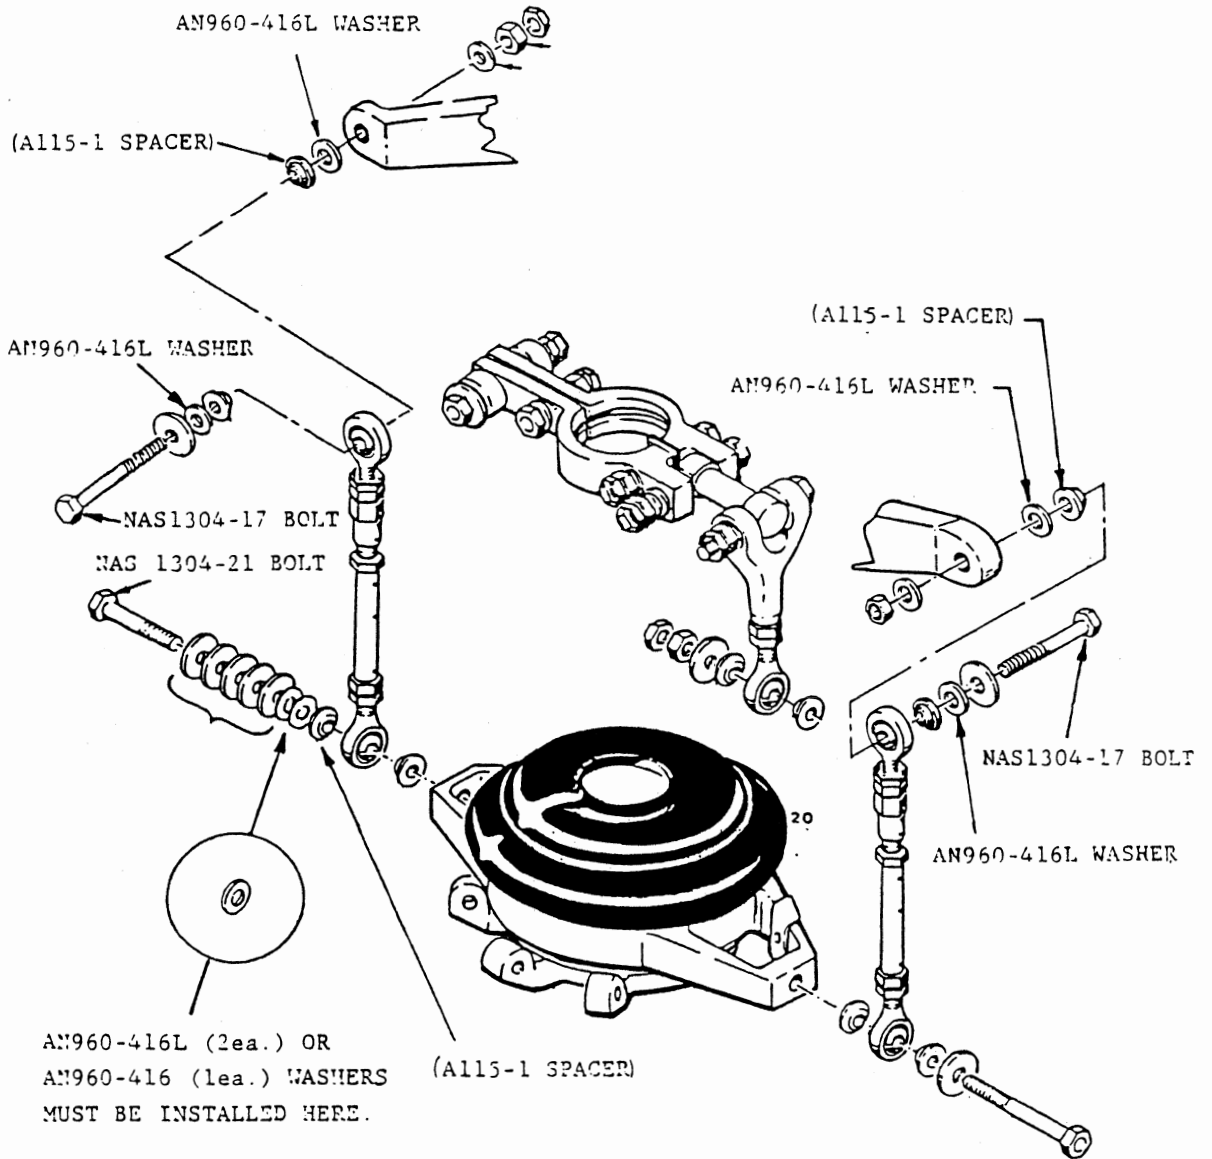
BACKGROUND: Without this change, it is possible for a mechanic to tilt the rotor head during ground handling to an extreme which could exceed the rod end bearing misalignment capability and possibly damage the bearing or bend the pitch link.

1. Install one each AN960-416L washer on each blade, between the A115-1 spacer and M.R. Blade Pitch horn if not already installed. Use NAS1304-17 bolt at locations indicated in figure on page two.
2. Check that two each AN960-416L washers or one AN960-415 washer are installed between the five large AN970-4 washers and A115-1 spacer on the lower rod end. Use NAS1304-21 bolt at location indicated in figure on page two.
3. Visual inspect M.R. Pitch Link is not bent.
