ROBINSON HELICOPTER COMPANY

SERVICE BULLETIN #47

SUBJECT: Inspection of A020-2 Upper Steel Tube Frame.

ROTORCRAFT AFFECTED: Aircraft S/N 0002 through S/N 0311 except those aircraft having A020-2 Frame S/N 400 and on installed.

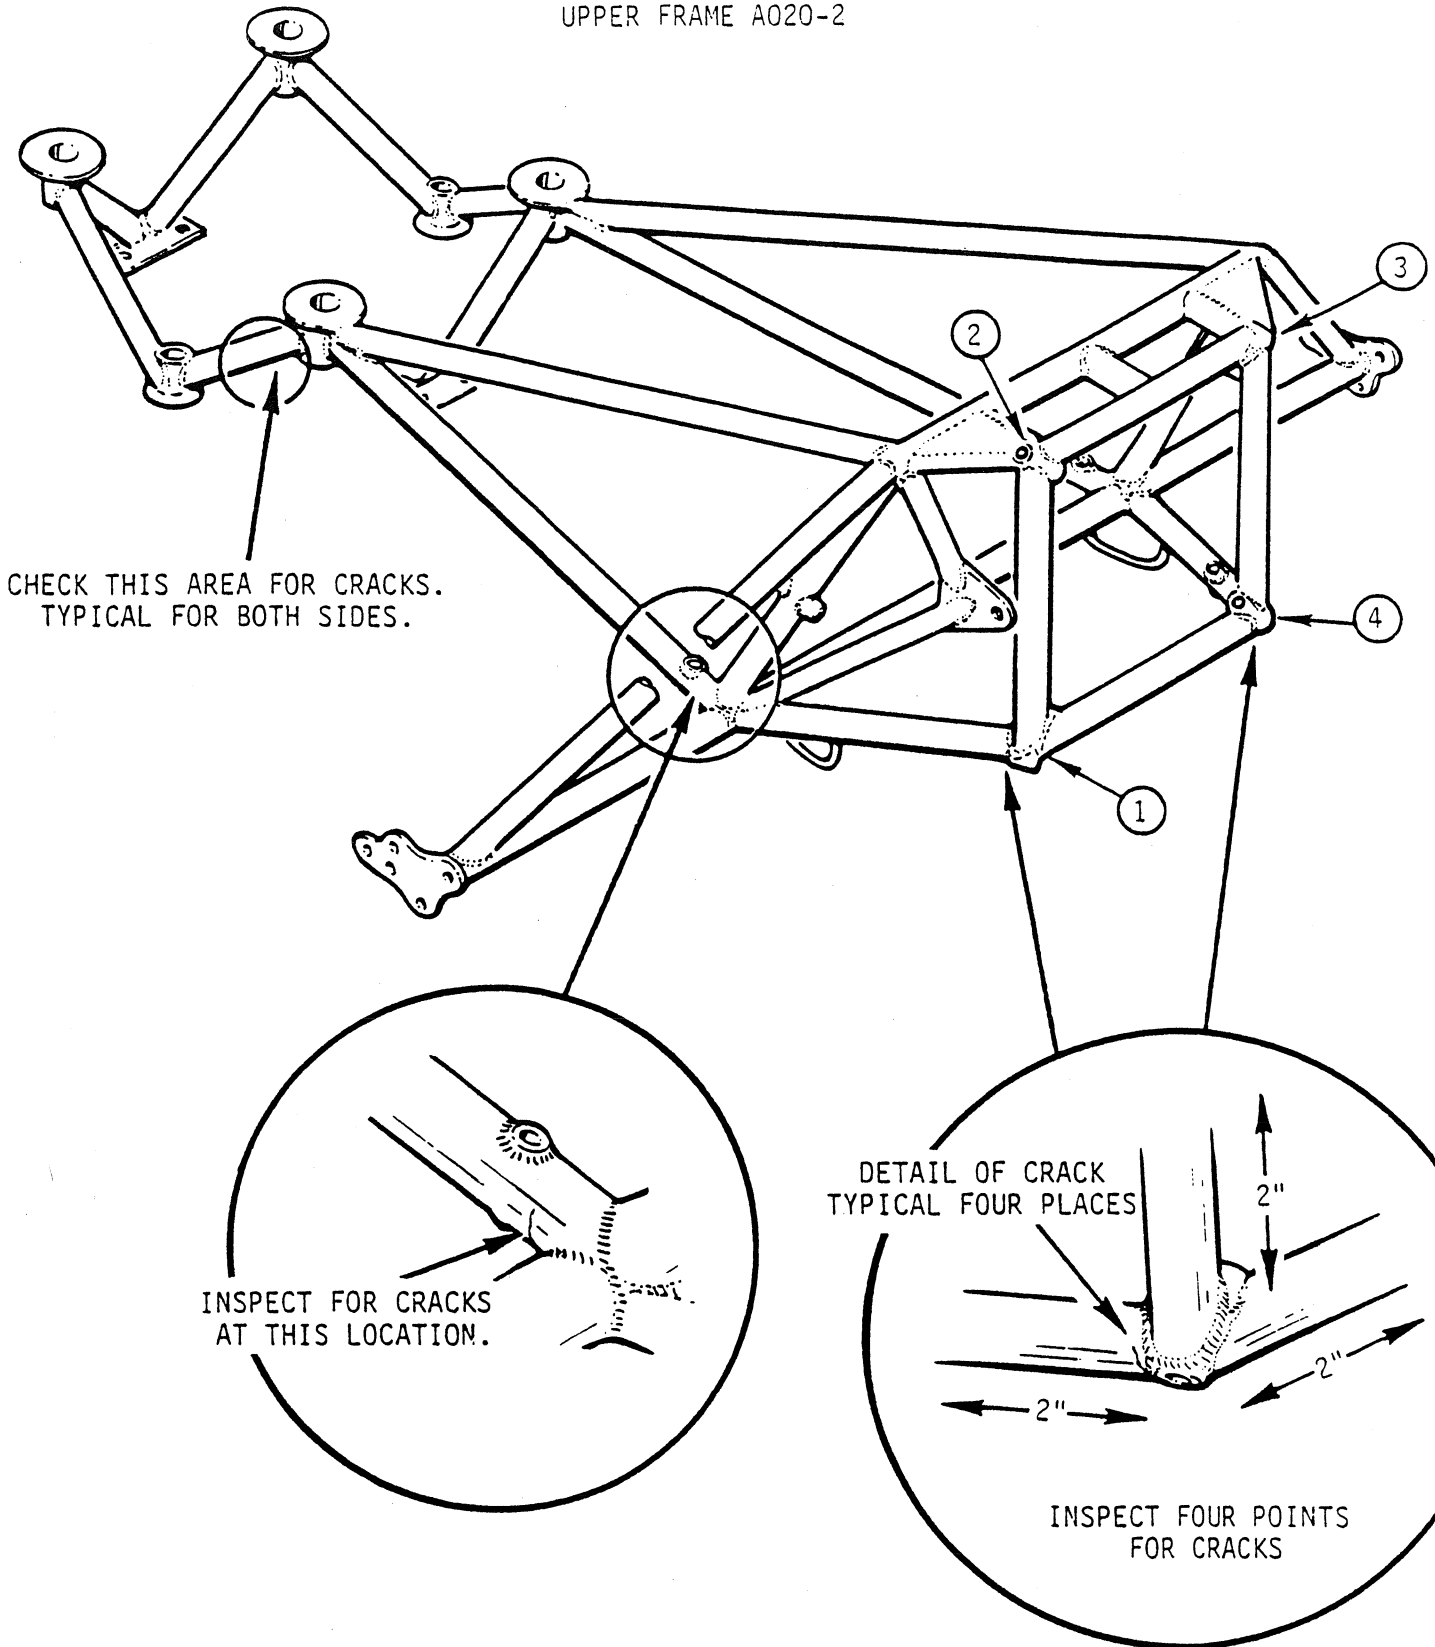
FIGURE 1

BACKGROUND: Fatigue cracks have been found in various locations on older A020-2 upper frames. These areas may have been overlooked during normal periodic inspections.

Inspect all tubes for cracks with particular attention to the areas indicated above.

1. Using inspection mirror and a high intensity light visually inspect all weld areas of the A020-2 frame. Pay particular attention to those areas shown in the following figure.
2. Check for cracks in and around each weld bead and along each steel supporting tube for at least two inches from the weld bead.
3. A logbook entry must be made by the licensed mechanic performing each 50 hour inspection.
4. Pilots should also be instructed to include a visual check of the A020-2 upper frame as part of their daily preflight. A logbook entry is not required for the pilot's preflight check.
5. If a crack is found, the frame must be immediately removed from service and replaced with a new frame. No repair of a cracked frame is allowed.
