SERVICE BULLETIN #48

SUBJECT: A723 Oil Cooler Lines

ROTORCRAFT AFFECTED: S/N 0002 thru S/N 0500 unless protective sleeves are already on the A723 oil cooler lines.

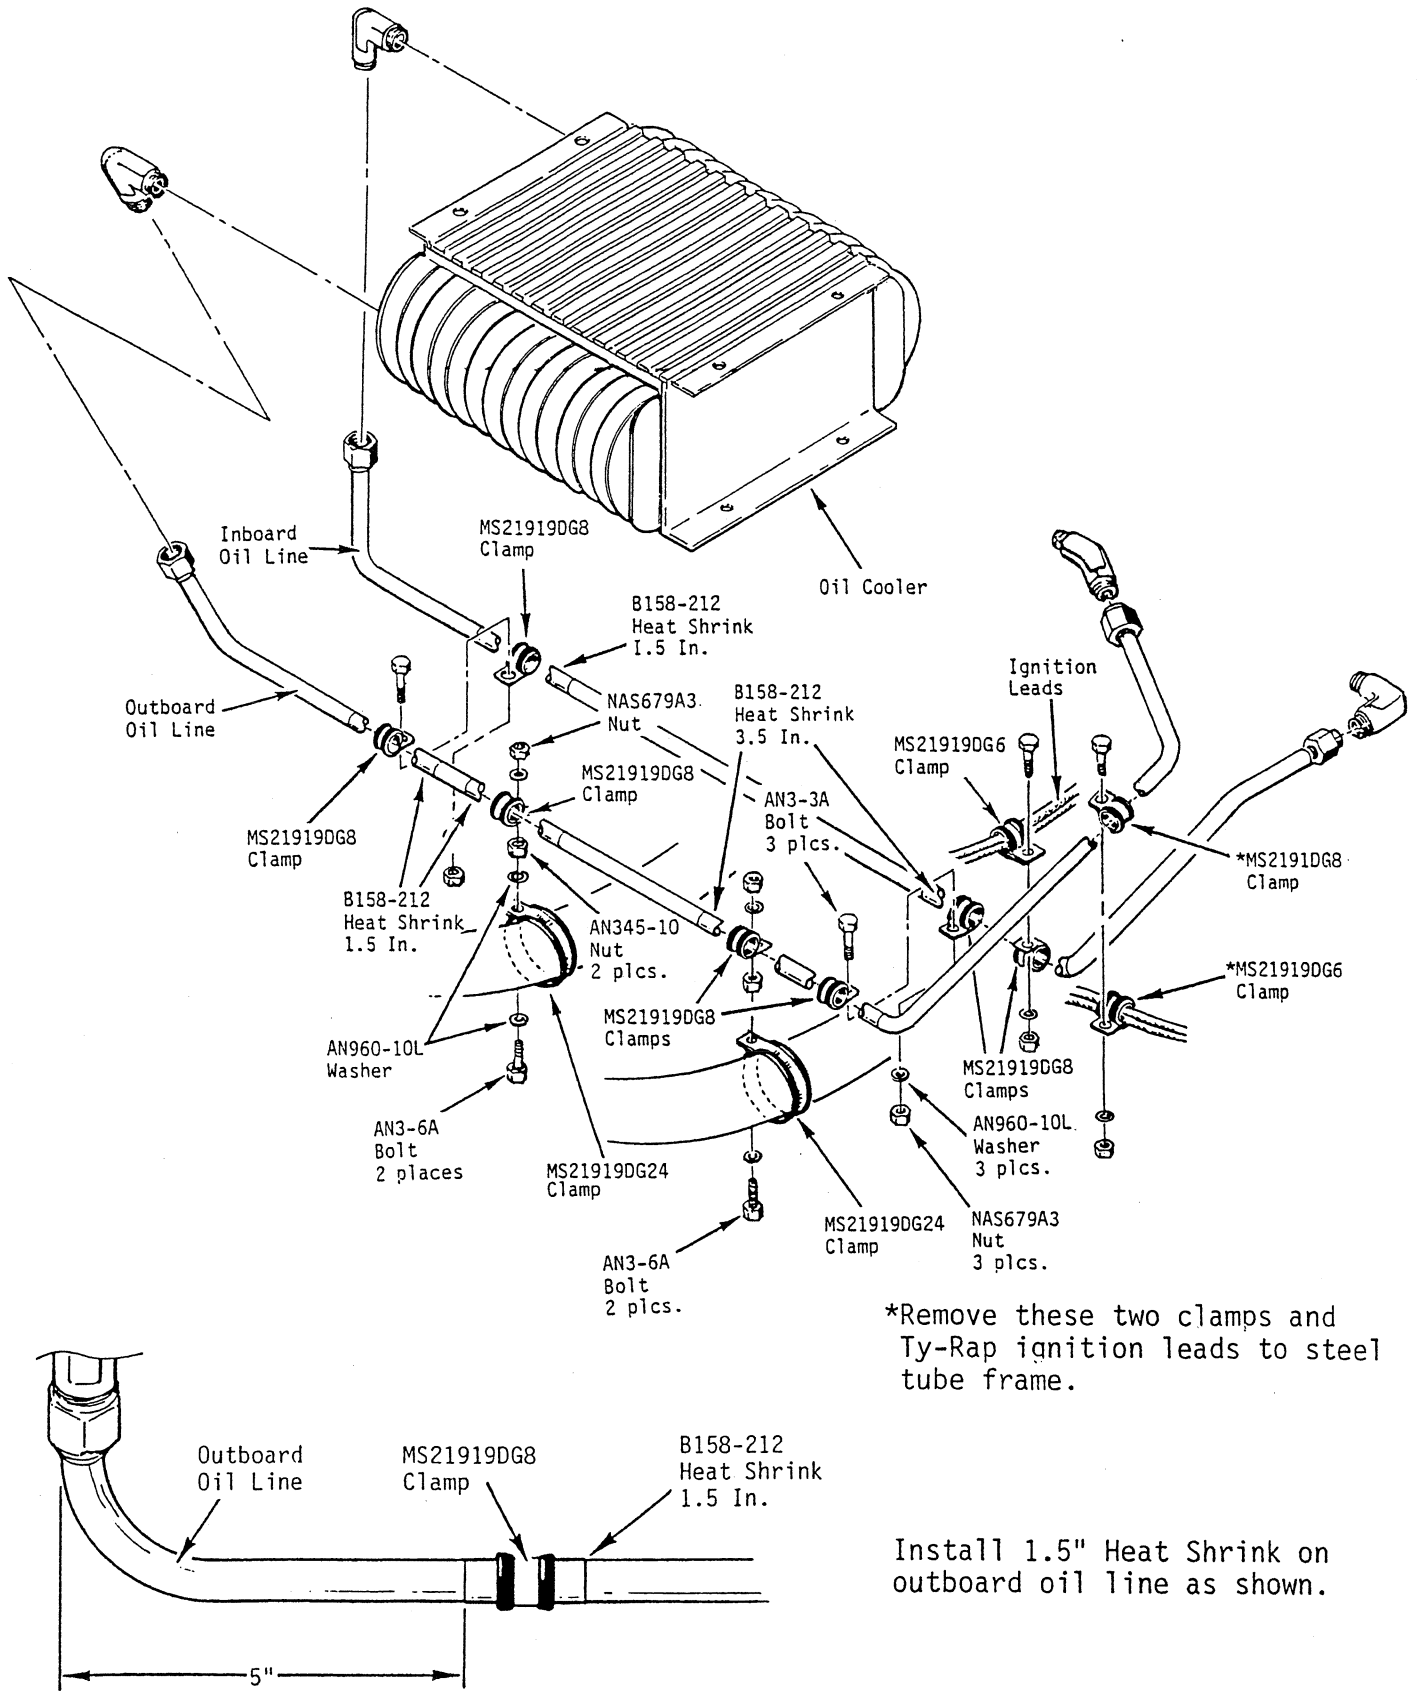
Figure 1

BACKGROUND: Cracking and chafing of A723 oil cooler lines have been reported, in three areas:

1. At or near the oil line flare fittings.
2. Underneath the MS21919DG8 clamps.
3. At the baffling that wraps underneath the #2 and #4 cylinder head. This baffling can contact the oil line if the A487-1 retainer hook fails or the baffling breaks loose.

6. Clean the protective sleeves and oil lines of any residual engine oil. Position the sleeves per figure 1. Apply heat with a heat shrink gun or suitable heat source. Reposition the sleeves as required while they are shrinking.

7. Install the new MS21919DG24 clamps onto the intake tubes. Install the new MS21919DG8 clamps over the protective sleeves on the oil lines. Secure the clamps per figure 1 without stressing or pre-loading the oil lines.

8. Secure the two ignition leads to the inboard oil line with a MS21919DG6 and a MS21919DG8 clamp, per figure 1. Do not secure any other items to the oil cooler lines. Reroute and resecure any items away from the oil lines.
