SERVICE BULLETIN #55DATE: 7 January 1987TO: All R22 Owners and OperatorsSUBJECT: R22 Harness Assy Buckle/ConnectorROTORCRAFT AFFECTED: R22 Alpha and Beta Helicopters Serial Numbers 436 thru 603 and any other R22 helicopter that had new Shoulder Harness Assys installed from 20 Aug 84 to 1 Jan 87.TIME OF COMPLIANCE: Perform Inspection Prior to Next Flight.BACKGROUND: AM-Safe, Inc. issued Service Bulletin No. A5001 which states that: "There is the possibility that under some conditions the connector may become dislodged from the buckle if a side load is placed on the assembly." If the buckle released prematurely in an accident, it could lead to serious injury of the occupant.

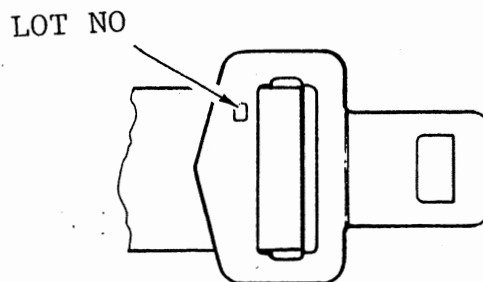
Check the connector for the lot number identification stamped at the location shown in the sketch. If the part is identified with an 04, replacement will be required per Part B. If the part is identified with any other lot number, enter in the log book.

TO REMOVE AND REPLACE CONNECTOR - Loop webbing up and away from load bar. Drive out roll pin with straight-sided punch. Load bar can now be moved axially and the opposite end moved up and pulled out. The new connector and load bar may now be installed and secured with a new roll pin.
