R22

SERVICE BULLETIN SB-78A

SUBJECT: Main Rotor Droop Stops and Teeter Stops

ROTORCRAFT AFFECTED: R22 helicopters S/N 0002 thru 2519.

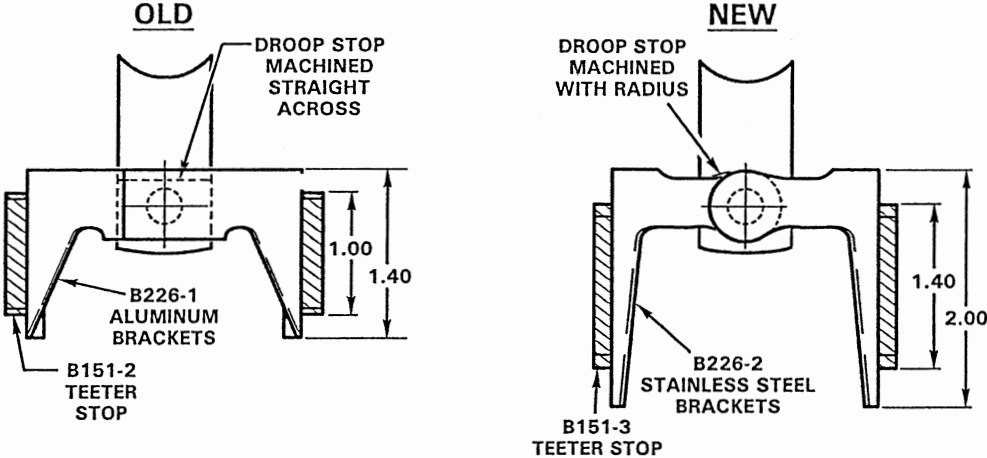
**DROOP STOPS AND BRACKETS**

Determine if SB-78 was complied with. See sketches on page 2 to identify older and newer parts. If SB-78 was not complied with, proceed with SB-78 reprinted below.
