R22

SERVICE BULLETIN SB-90A

DATE: 01 August 2001 **REV A:** 10 June 2002

SUBJECT: Tail Rotor Pitch Control Bearings

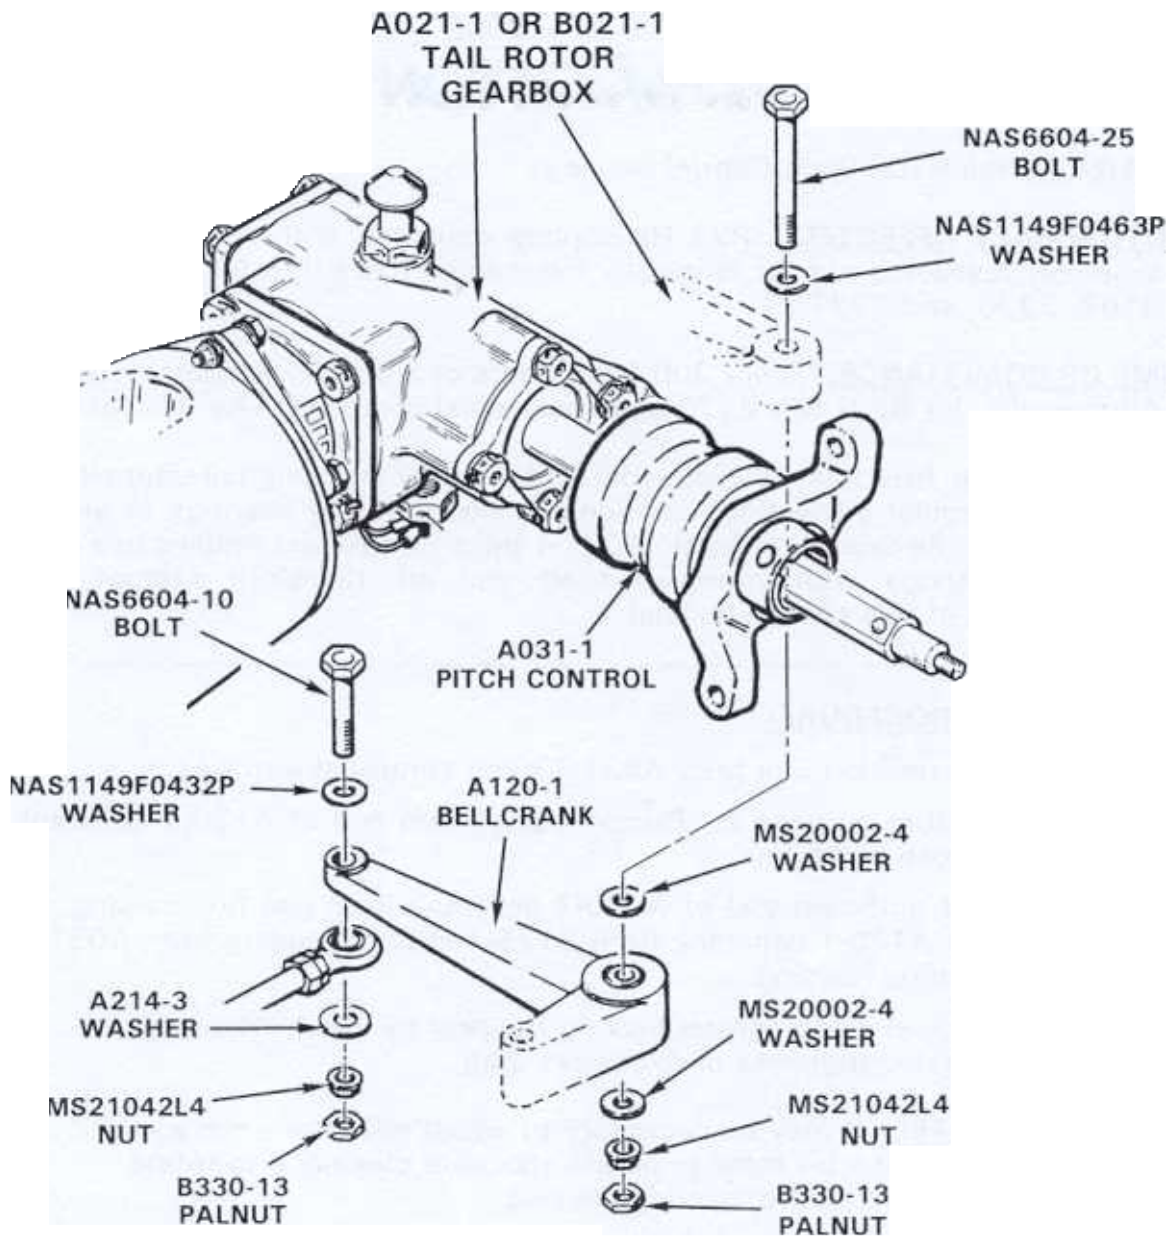
BACKGROUND: RHC has received reports of rough or dragging tail rotor pitch control bearings. Regular inspections can identify deteriorating bearings to avoid an in-flight failure. Revision K or later A031-1 pitch control assemblies use corrosion-resistant bearings with improved seals and are therefore exempt from the requirements of this service bulletin.

1. Refer to figure on page 2. Disconnect inboard end of A120-1 bellcrank from tail rotor push-pull tube.
2. Disconnect outboard end of A120-1 bellcrank from gearbox casting. Do not disconnect A120-1 bellcrank from A125-1 stud protruding from A031-1 pitch control bearing housing.
3. Rotate A031-1 pitch control bearing housing by hand. Housing should rotate freely with no roughness or excessive drag.

4. If pitch control bearings exhibit roughness or excessive drag, replace A031-1 pitch control per R22 Maintenance Manual Section 8.560. Otherwise, proceed to step 5.
5. Reconnect outboard end of A120-1 bellcrank to gearbox casting as shown in figure using hardware removed in step 2. Torque MS21042L4 nut to 120 in.-lb (includes locking torque) and B330-13 palnut to 11-25 in.-lb. Torque stripe.
6. Reconnect inboard end of A120-1 bellcrank to tail rotor push-pull tube as shown in figure using hardware removed in step 1. A214-3 (large diameter) safety washer must be under nut. Torque MS21042L4 nut to 120 in.-lb (includes locking torque) and B330-13 palnut to 11-25 in.-lb. Torque stripe.
7. Make appropriate maintenance record entries.
