R22 SERVICE BULLETIN SB-99

DATE: 30 April 2010

SUBJECT: Gascolator Assembly

ROTORCRAFT AFFECTED: R22 helicopters S/N 0002 thru 4339.

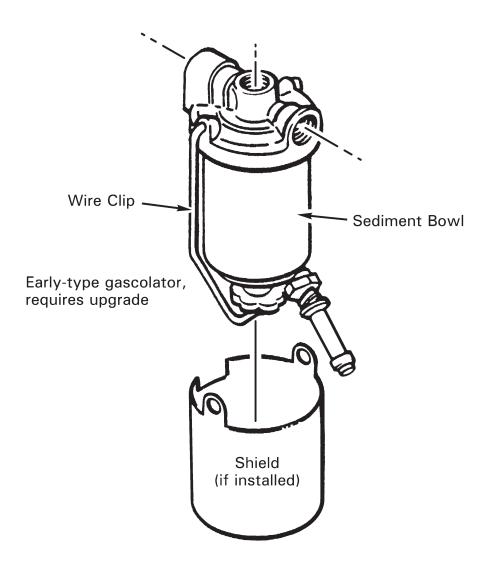
BACKGROUND: Earlier gascolator assemblies secure the sediment bowl to the top with a wire clip. This service bulletin requires replacing clip-type gascolator tops with a threaded top, collar, and ring for improved security of the sediment bowl.

Determine if gascolator sediment bowl is secured with wire clip as shown on next page. If bowl is secured with wire clip then install KI-193-4 kit per instructions. Kit instructions are available online at: <u>www.robinsonheli.com/servelib.htm</u>.

Parts: KI-193-4 kit: \$58, if ordered by 31 July 2010 (R22 helicopters S/N's 4236, 4241, 4250, and 4253 & subsequent are covered under warranty).
