R44

SERVICE BULLETIN SB-16

SUBJECT: Replacement of C309-1 Panel Assembly with V-belt Restraint

ROTORCRAFT AFFECTED: R44 Helicopters S/N 0002 thru 0240

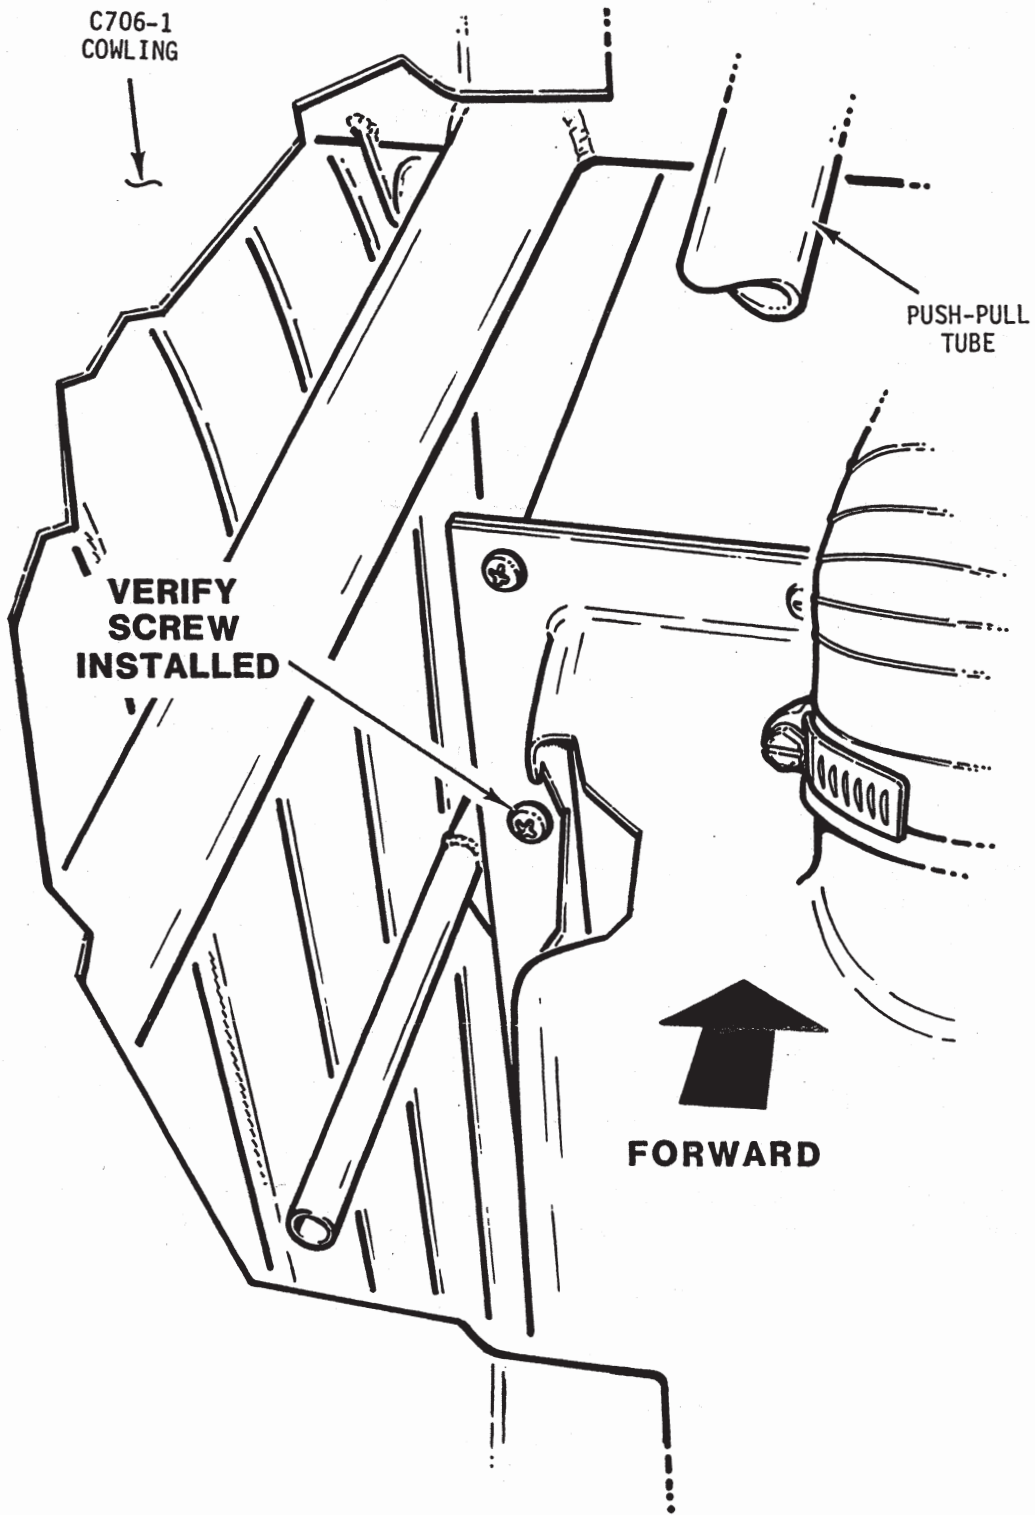
BACKGROUND: Cracks have been found in the support structure for the right-hand V-belt restraint tube. Failure of the restraint can cause damage to the V-belts which could lead to their premature failure. The C309-1 panel assembly has been redesigned to prevent cracking at the V-belt restraint and in other areas where cracks have been found.

- 1) Visually inspect right-hand inboard flange of the C236-1 upper scroll as shown in figure on page 2. If indicated screw is installed, no further action is required. If no screw is installed at that location, the C309-1 panel assembly must be replaced. (A mirror is required to view flange if C706-1 cowling is installed.)
- 2) If the C309-1 panel assembly requires replacement, reference helicopter serial number and order one KI-105 kit. Install panel assembly using parts and instructions supplied with the kit.
