R44

SERVICE BULLETIN SB-19

DATE: 16 April 1997

SUBJECT: Lateral Cyclic Trim Assembly Spring Shaft Wear

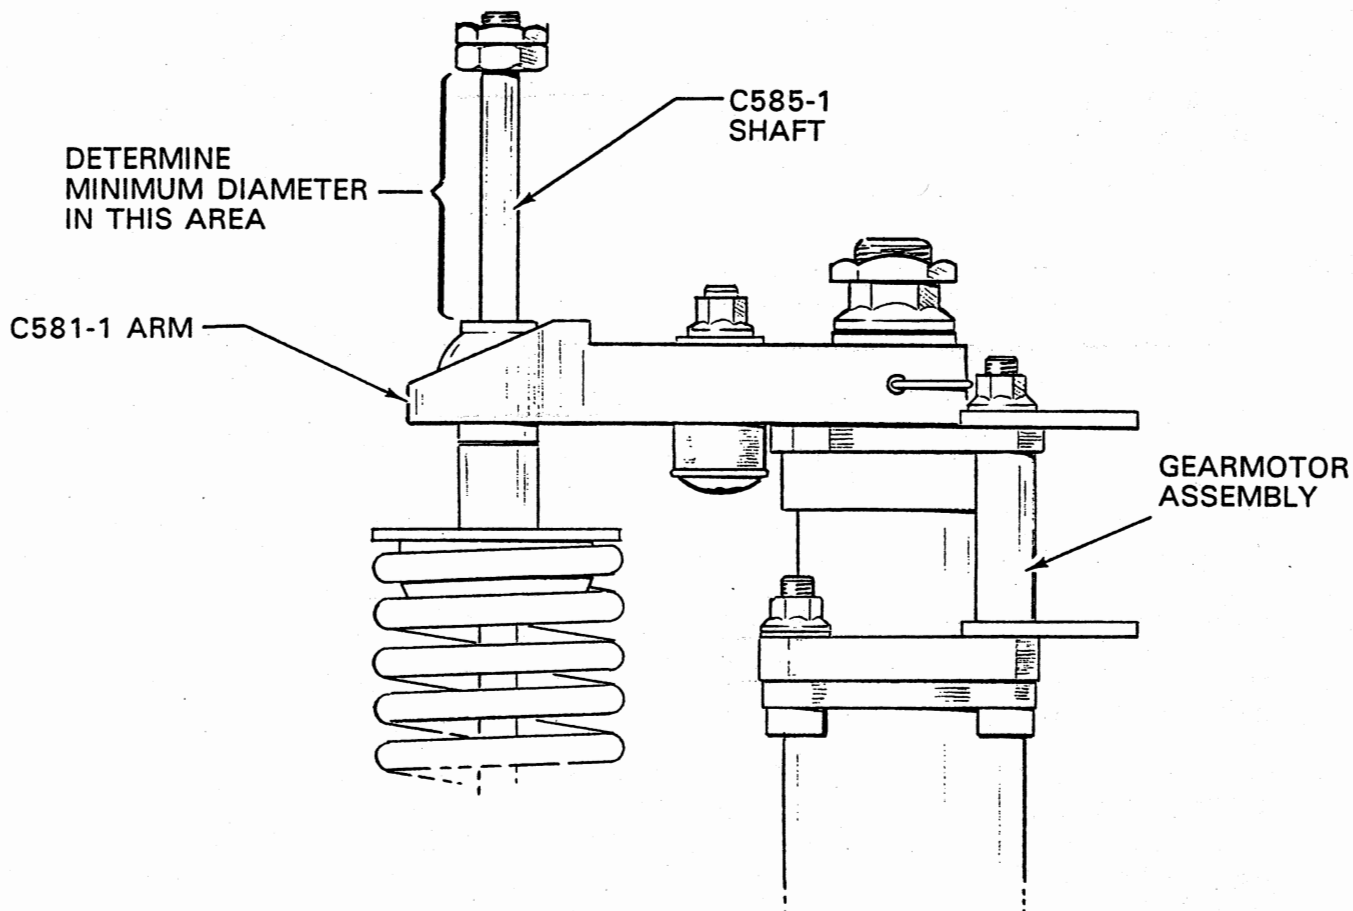
FIGURE 1

BACKGROUND: RHC has received reports of excessive C585-1 shaft wear. Excessive wear can be caused by a high-friction spherical bearing in C581-1 revision H or prior arms. The KI-109 kit includes a C581-1 arm with a low-friction bearing.

4. Move cyclic stick to left stop to compress trim spring.
5. Refer to figure 1. Determine minimum diameter of exposed portion of C585-1 shaft by measuring at several places.

6. Diameter of new shaft is 0.248 inch. If shaft diameter decreased more than 0.001 inch per 100 hours time-in-service OR if shaft diameter is less than 0.238 inch, order KI-109 kit and replace C585-1 shaft and C581-1 arm using instructions supplied with kit. Note: if minimum shaft diameter is less than 0.218 inches, shaft must be replaced prior to further flight.
