R44

SERVICE BULLETIN SB-26

SUBJECT: Lateral Cyclic Trim Assembly

ROTORCRAFT AFFECTED: R44 Helicopters S/N 0002 thru 0420 and 0425, 0426, and 0427.

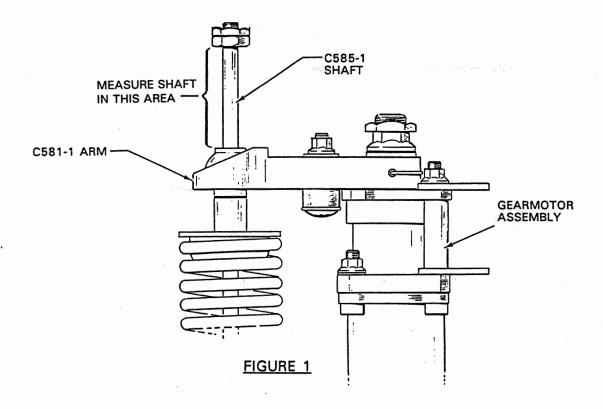
BACKGROUND: RHC has received reports of excessive C585-1 shaft wear. Excessive wear can cause binding of the flight controls. The KI-129 kit contains a redesigned C056-1 spring assembly with Teflon-lined bearings to prevent excessive wear or galling.

- 1. Switch cyclic trim system on. Push and hold cyclic stick against right stop until motor stops, then switch trim off. (This will apply maximum right trim.)
- Remove avionics from mounting trays. Detach intercom system from C641 avionics face and remove avionics face.
- 3. Remove radio rack (not necessary to disconnect airframe wiring from radio trays to remove radio rack).
- Move cyclic stick to left stop to compress trim spring and expose upper part of shaft.
- Refer to Figure 1. Measure shaft diameter in several places. If shaft diameter varies more than 0.004 inches in any 0.50 inch of length, C056-1 spring assembly must be replaced before further flight.
- 6. If shaft diameter is within limits specified above, clean and lubricate with A257-1 grease.

- 7. Install radio rack, avionics face, and avionics.
- 8. Order KI-129 Kit (reference helicopter serial number).
- 9. Replace C056-1 spring assembly per kit instructions and enter SB-26 complied with in aircraft logbook. Return old C056-1 spring assembly to RHC.
