R44

SERVICE BULLETIN SB-38

DATE: 3 March 2000

SUBJECT: Hydraulic Reservoir Sequence Valve Inspection

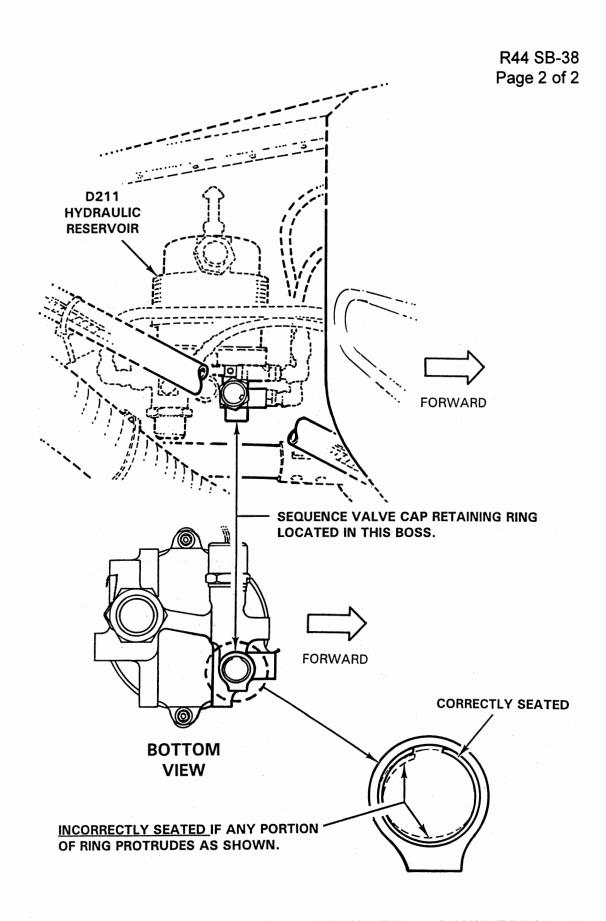
BACKGROUND: A hydraulic reservoir sequence valve failed under pressure during testing at the factory due to improper installation of the valve cap retaining ring. An inflight failure would cause sudden loss of hydraulic pressure. Inspection of the retaining ring is required to verify proper installation.

- 1. Refer to figure on page 2. Using an inspection mirror and flashlight, inspect sequence valve cap retaining ring on bottom of D211 hydraulic reservoir. Verify ring is fully seated in groove. Ring should protrude equally from groove all around.
- 2. If ring is not properly seated, use a cylindrical tool of 0.620 inch to 0.670 inch outside diameter (a standard 7/16 inch socket should work) and push up firmly on retaining ring, then repeat step 1.
- 3. If unable to fully seat retaining ring or unsure of proper retaining ring installation, contact RHC Technical Support.
- 4. Make appropriate maintenance record entries.
