R44

SERVICE BULLETIN SB-43A

SUBJECT: Tail Rotor Pitch Control Bearings

ROTORCRAFT AFFECTED: R44 Helicopters equipped with C031-1 pitch control assembly revision G or prior (originally installed on R44s thru S/N 1208 except S/N 1143, 1165, 1183, 1189, 1192, 1196, 1197, 1198, 1200, 1203, and 1204).

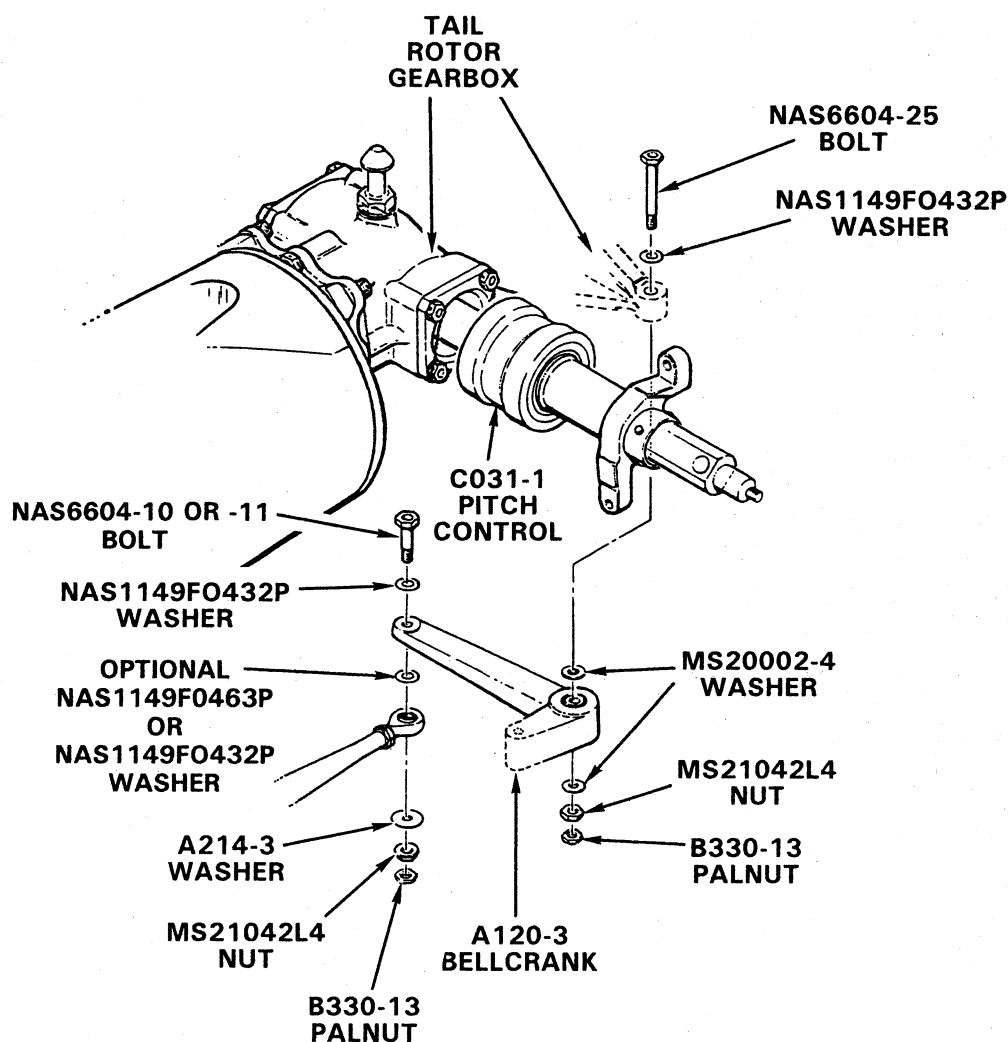
BACKGROUND: RHC has received reports of rough or dragging tail rotor pitch control bearings. Regular inspections can identify deteriorating bearings to avoid an in-flight failure. Revision H or later C031-1 pitch control assemblies use corrosion-resistant bearings with improved seals and are therefore exempt from the requirements of this service bulletin.

3. Rotate C031-1 pitch control bearing housing by hand. Housing should rotate freely with no roughness or excessive drag.
4. If pitch control bearings exhibit roughness or excessive drag, replace C031-1 pitch control per R44 Maintenance Manual Section 8.560. Otherwise, proceed to step 5.

1. Refer to figure on page 2. Disconnect inboard end of A120-3 bellcrank from tail rotor push-pull tube.
2. Disconnect outboard end of A120-3 bellcrank from gearbox casting. Do not disconnect A120-3 bellcrank from C125-1 stud protruding from C031-1 pitch control bearing housing.

5. Reconnect outboard end of A120-3 bellcrank to gearbox casting as shown in figure using hardware removed in step 2. Torque MS21042L4 nut to 120 in.-lb (includes locking torque) and B330-13 palnut to 11-25 in.-lb. Torque stripe.

6. Reconnect inboard end of A120-3 bellcrank to tail rotor push-pull tube as shown in figure using hardware removed in step 1. A214-3 (large diameter) safety washer must be under nut. Torque MS21042L4 nut to 120 in.-lb (includes locking torque) and B330-13 palnut to 11-25 in.-lb. Torque stripe.

Some aircraft may have an optional NAS1149F0463P thick washer or NAS1149F0432P thin washer to ensure 0.050 inch minimum clearance between tail rotor push-pull tube and bulkhead casting. An NAS6604-11 bolt may be used in place of NAS6604-10 bolt to ensure proper thread engagement.
