SERVICE BULLETIN SB-48

DATE: 11 September 2003

SUBJECT: R44 II Fuel Control Safety Wire

ROTORCRAFT AFFECTED: R44 II Helicopters S/N 10001 thru 10148

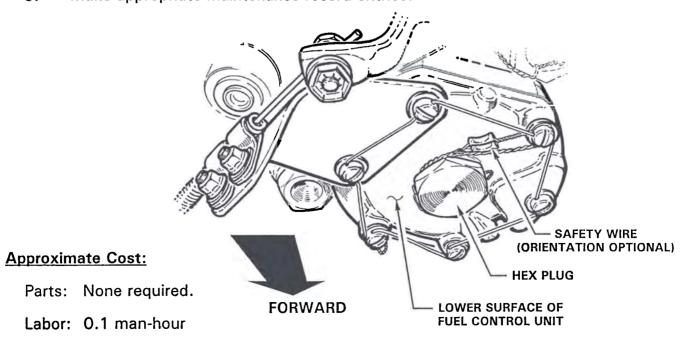
<u>BACKGROUND:</u> During production flight testing, an R44 II experienced loss of power when the hex plug on the lower surface of the fuel control unit came loose. It was determined that the safety wire securing the plug was not installed.

- 1. Look at lower surface of fuel control unit from under helicopter. (It is not necessary to remove engine cowling.) Verify large hex plug is secured by safety wire per figure below.
- 2. If safety wire is missing, contact RHC Technical Support for further instructions.
- 3. Make appropriate maintenance record entries.
