R44

SERVICE BULLETIN SB-50

SUBJECT: R44 II Oil Line Clamp

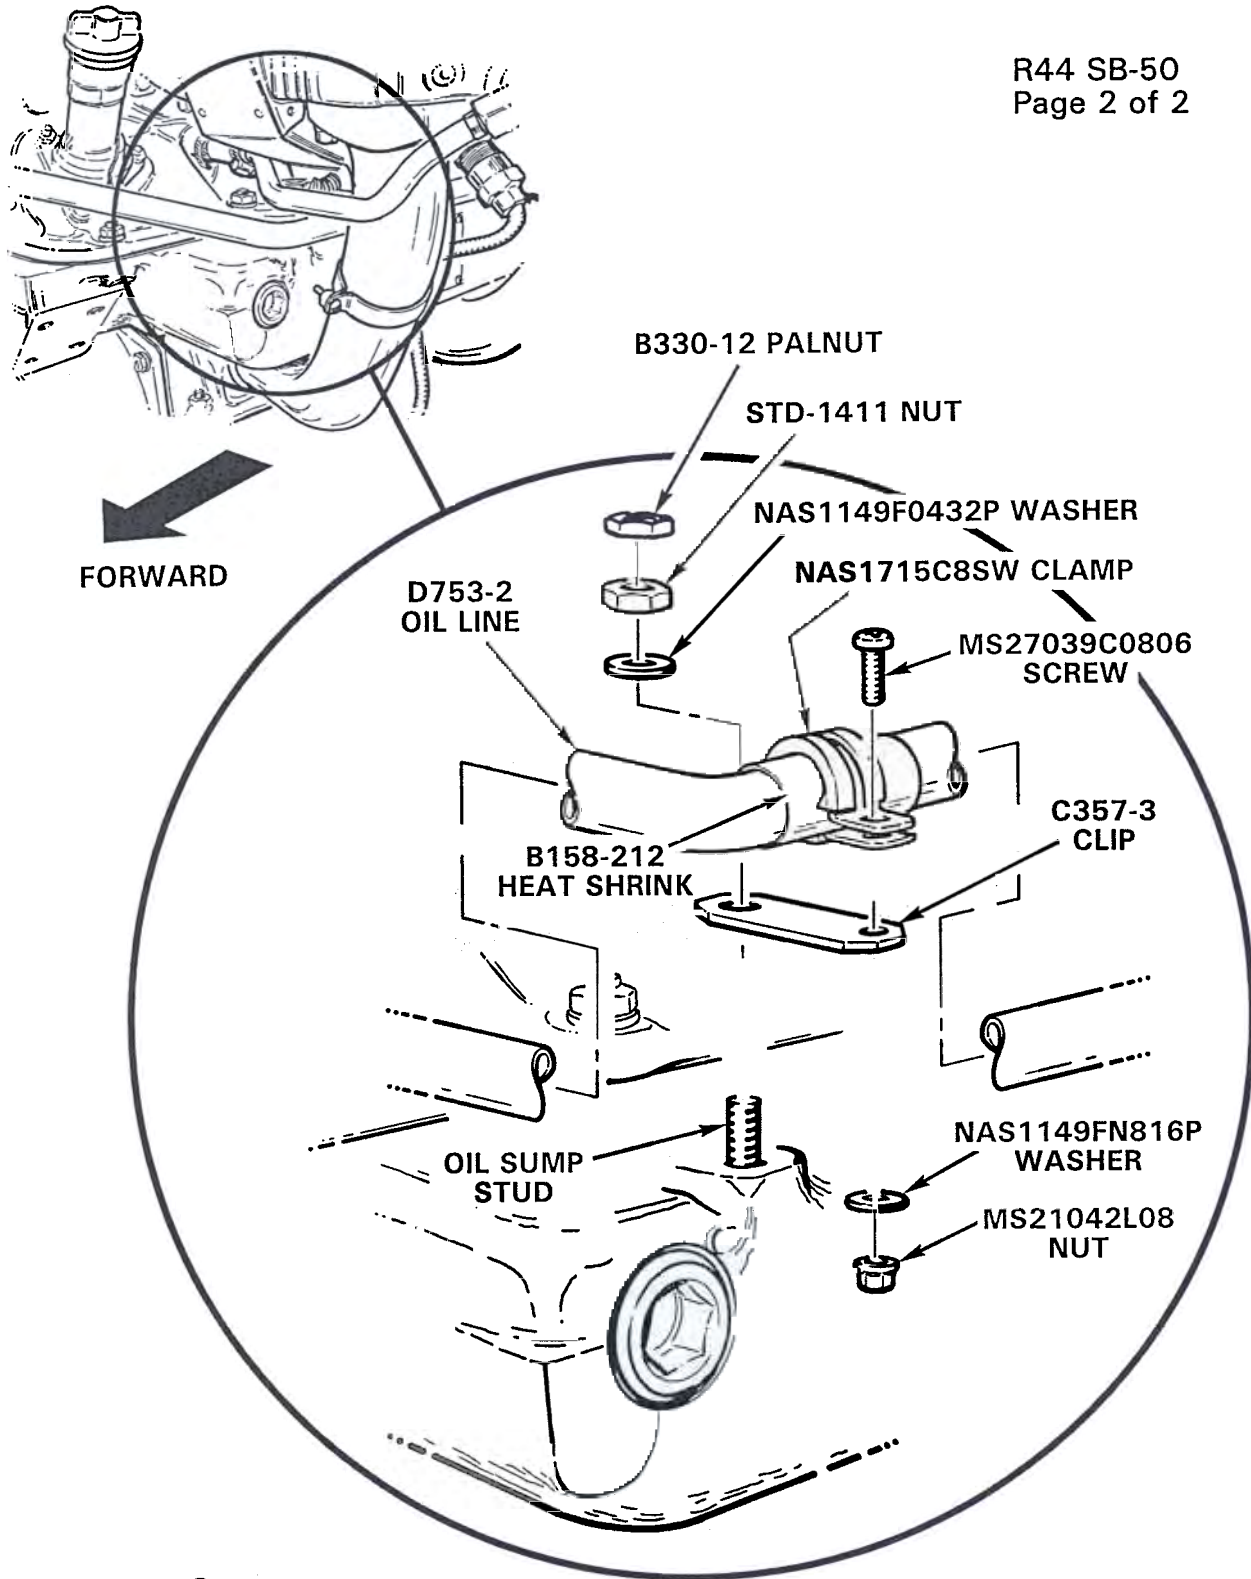
BACKGROUND: Excessive vibration has been observed on the auxiliary oil cooler supply line on some engines. The vibration is eliminated by adding a second clamp to the oil line.

- 1 Remove left-hand engine cowling. Refer to figure on page 2
2. Disconnect D753-2 oil line's forward nut, slide nut aft, and clean oil line in area where clamp is to be installed.
3. Slide B158-212 heat shrink over forward end of oil line, exercising care to prevent oil contamination. Center heat shrink at oil sump stud and activate with heat gun.
4. Reconnect oil line nut. Torque to 450-500 in-lb and torque stripe.
5. Install C357-3 clip as shown in figure and secure with NAS1149F0432P washer and STD-1411 nut torqued to 96 in-lb. Install B330-12 palnut and torque to 11-25 in-lb.
6. Install NAS1715C8SW clamp on oil line and secure to C357-3 clip using MS27039C0806 screw, NAS1149FN816P washer, and MS21042L08 nut as shown in figure.
7. Ground run helicopter and verify no oil leaks.
- 8 Install engine cowling.
9. Make appropriate maintenance record entries
