R44

SERVICE BULLETIN SB-53

SUBJECT: C046-18 Frame Tube

ROTORCRAFT AFFECTED: R44 Helicopters S/N 1160 thru 1395 except 1161, 1165, and 1198. R44 II Helicopters S/N 10001 thru 10381 except 10376 thru 10379.

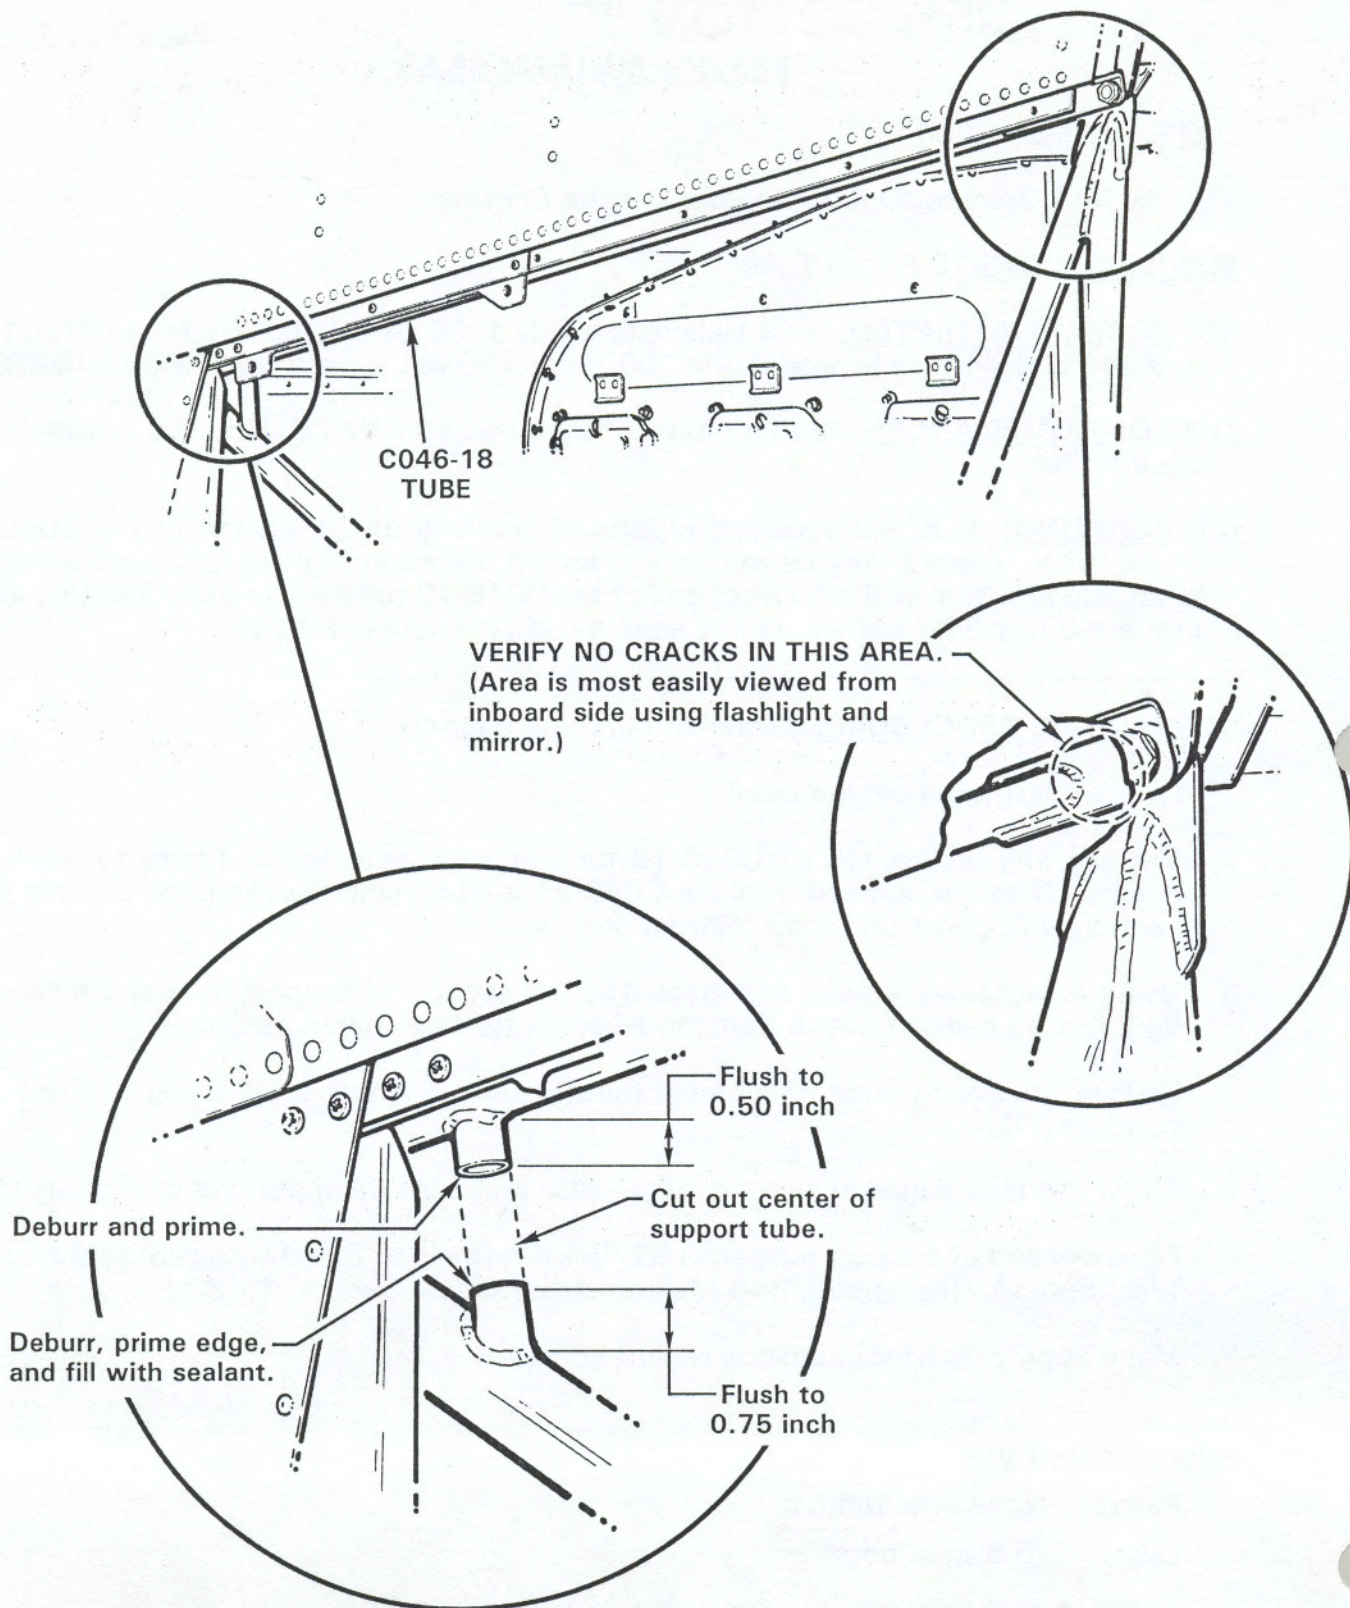
BACKGROUND: RHC has received reports of cracking of the aft tab of the C046-18 frame tube. Cracks may be due to a resonant vibration in the tube. Removing the short support tube at the forward end of the C046-18 tube will reduce vibratory loads in the tube. (Older frames do not have the short support tube.)

1. Remove left-hand engine cowl.
2. Visually inspect aft tab of C046-18 tube in area indicated in figure to verify no cracks. If tab is cracked, replace C046-21 lower frame assembly or contact RHC Technical Support for repair instructions.
3. Using a hacksaw, remove and discard center section of support tube as indicated in figure. Use caution not to damage adjacent tubes or cabin structure.
4. De-burr remaining ends of support tube and clean inside ends using acetone and cotton swab.
5. Prime exposed edges of support tube. Also prime inside upper end of support tube.
6. Fill lower end of support tube with B270-1 (Pro-Seal) or B270-9 sealant (3M Scotch-Weld Epoxy). (Reference R44 Maintenance Manual Section 1.480.)
7. Make appropriate maintenance record entries.
