R44 SERVICE BULLETIN SB-80

SUBJECT: Pop-Out Float Cylinder Valve

ROTORCRAFT AFFECTED: R44 and R44 II helicopters with pop-out floats (Clippers), and spare pop-out float cylinders, equipped with D757-1 (gray) valve assembly containing D758-1 Revision C or prior housing assembly (Revision letter follows stamped part number). Black valves are not affected.

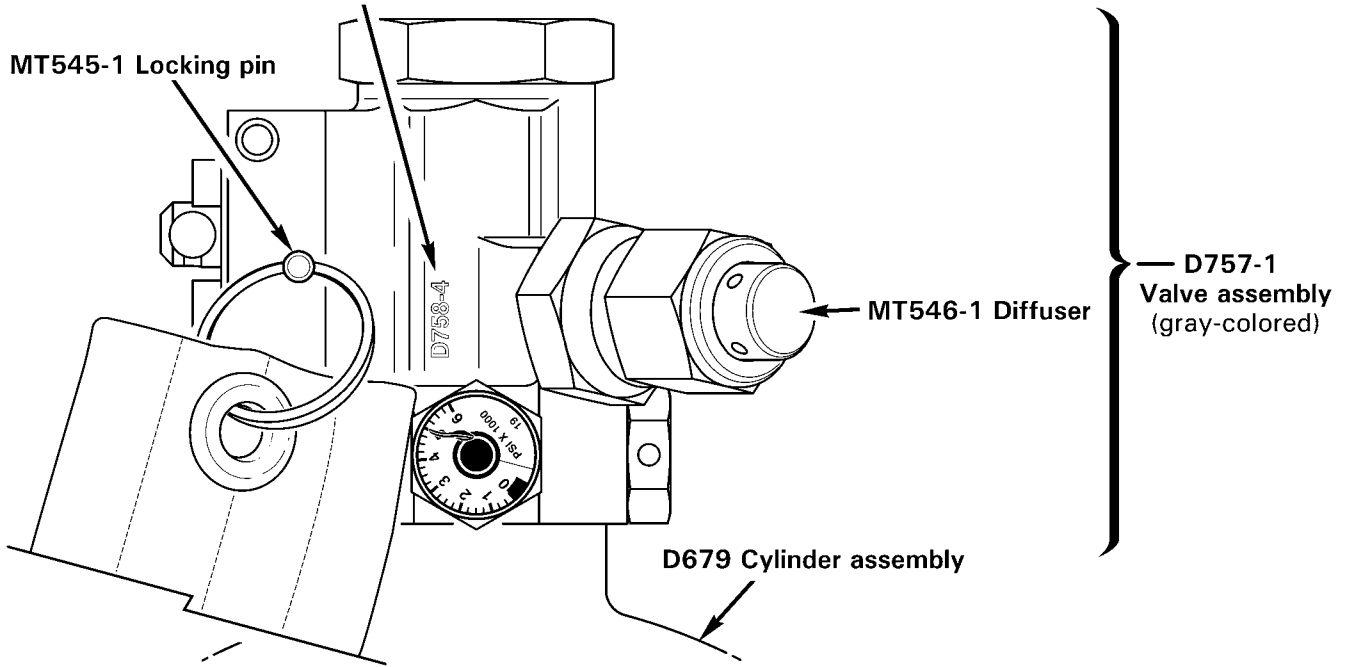
FIGURE 1

BACKGROUND: During a factory test of pop-out floats, the floats failed to inflate due to a stuck cylinder valve. This bulletin requires earlier D757-1 valve assemblies be upgraded to ensure proper function.

D758-4 Housing part number
will be engraved adjacent to
pressure gage.

1. Refer to Figure 1. If D757-1 (gray) valve assembly is engraved with "D758-4," or if gray valve has a data plate indicating B900-8 modification, the requirements of this bulletin have been complied with and no further action is required.
2. If gray valve is not engraved with "D758-4" or does not have a data plate indicating B900-8 modification:
 - a. Verify a local facility (such as a welding gas supplier) is available to fill cylinder with 5000 psi helium and order one KI-211 Valve Replacement Kit, or
 - b. Order one D679-3R (filled, overhauled-exchange) cylinder assembly.

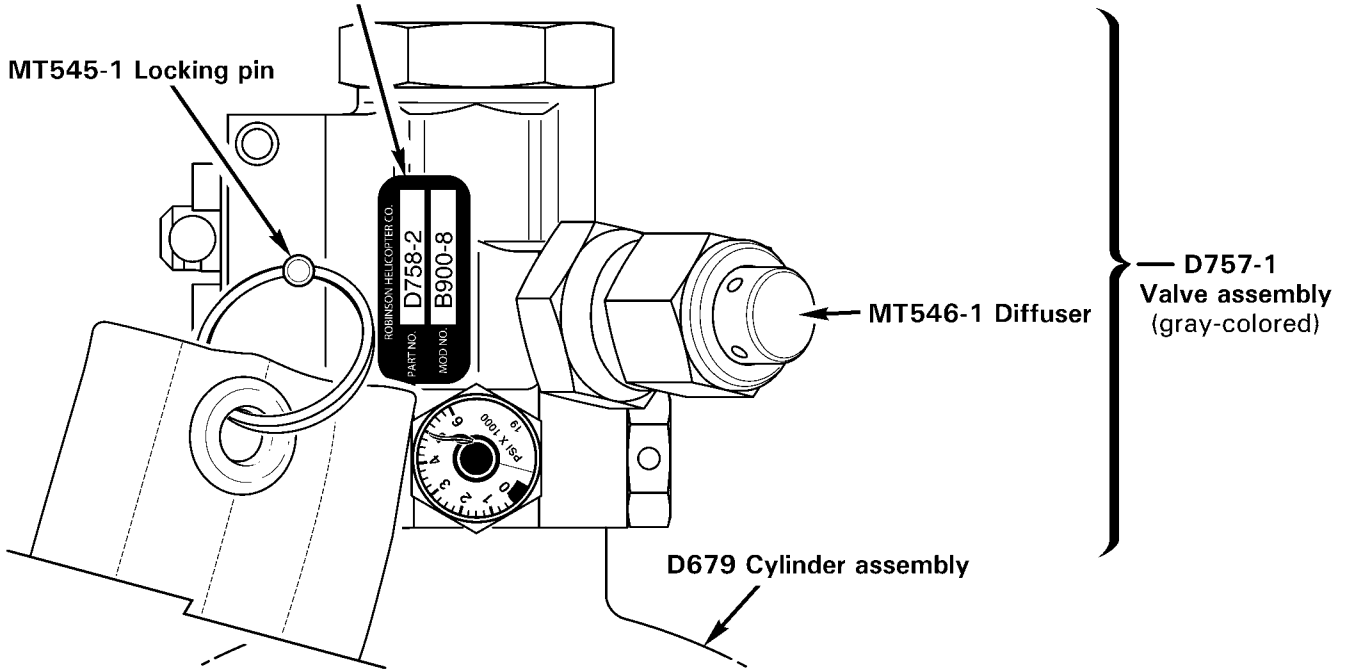
Data plate indicating B900-8
modification will be located
adjacent to pressure gage.
