R44 SERVICE BULLETIN SB-83

DATE: 30 May 2012

SUBJECT: Tail Rotor Blade Fatigue Cracks

ROTORCRAFT AFFECTED: R44 and R44 II helicopters with P/N C029-1 or C029-2 tail rotor blades installed.

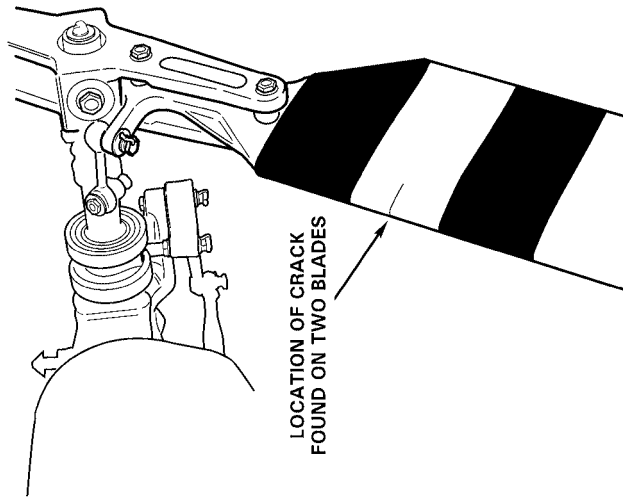
Cracks have been found in C029-2 tail rotor blades at the leading edge in the most inboard white paint stripe (see figure). The cracks were found by pilots during preflight checks. Cracks are caused by high fatigue stresses during maneuvers with large left pedal inputs. C029-1 blades have the same construction and therefore would also be susceptible to cracking.

Prior to each flight, inspect leading edges of tail rotor blades for cracks. Wipe blades clean if necessary to make sure potential cracks are visible.

To reduce fatigue stress damage to the blades, avoid maneuvers which require large left pedal inputs.
