R44 SERVICE BULLETIN SB-85

DATE: 31 August 2012

SUBJECT: C771-1 Air Filter Deterioration

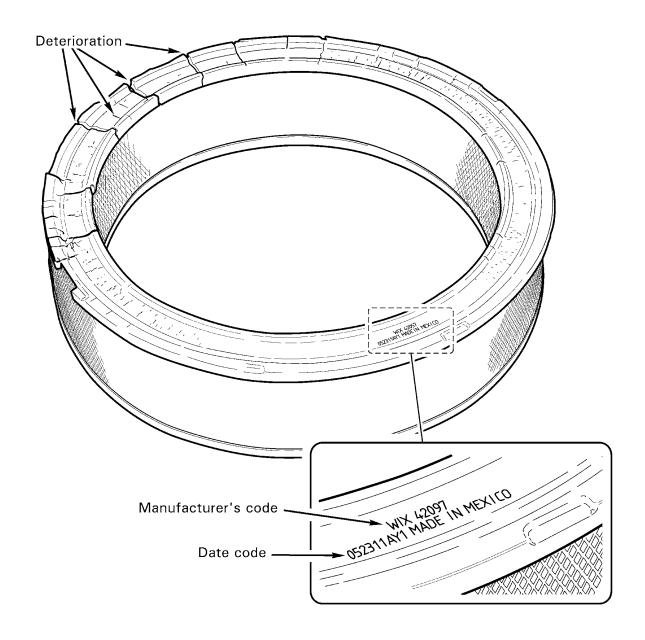
BACKGROUND: RHC has received reports of engine air filter deterioration in service. Cracks were found in the rubber that seals the upper and lower surfaces of the filter in the airbox. Reports have so far been isolated to a specific manufacturing lot. This bulletin requires air filter inspection and replacement of specified filters.

- 1. Open airbox, and remove C771-1 air filter.
- 2. Refer to figure on page 2. Filter is unairworthy if date code is 052311AY1 or if rubber has deteriorated as shown.
- 3. If filters with date code other than 052311AY1 are found with deteriorated rubber, report finding to RHC Technical Support.
- 4. Install airworthy filter and close airbox.
- 5. Make appropriate maintenance record entries.
- Remove all filters with date code 052311AY1 from spares inventory.
