**R44 SERVICE BULLETIN SB-88**

**SUBJECT:** Landing Gear Attach Nuts

**ROTORCRAFT AFFECTED:** R44 helicopters S/N 2353 thru 2374 and R44 II helicopters S/N 13661 thru 13747.

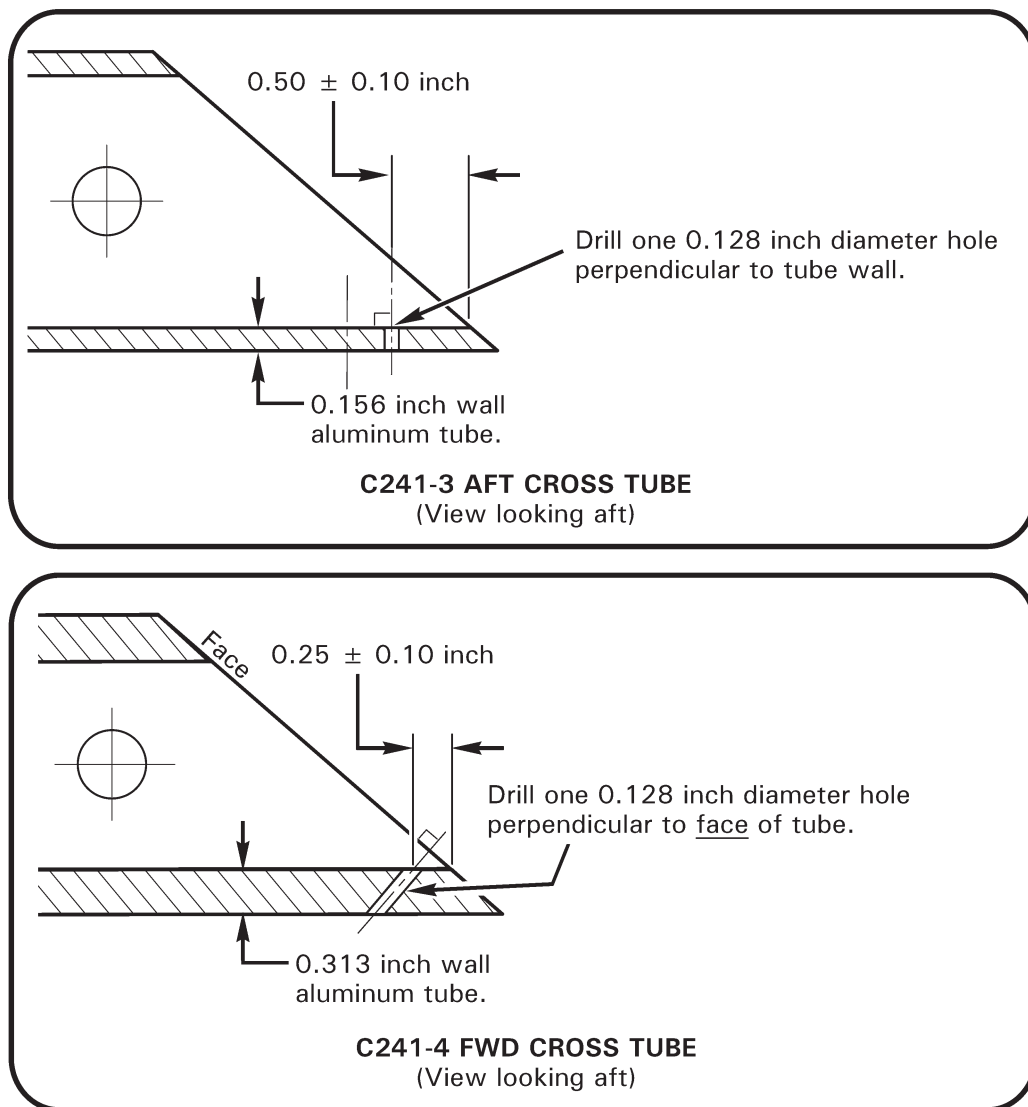
**FIGURE 1**

**BACKGROUND:** RHC has received a report of a cracked NAS1291-7 nut attaching the landing gear assembly to the helicopter. For helicopters with affected landing gear, this bulletin requires replacing NAS1291-7 landing gear attach nuts with D210-7 nuts, drilling a vent hole in each cross tube, and installing clear plastic rain caps to facilitate fastener inspection.

5. Refer to Figure 1. Lay out vent hole location on left side of C241-3 (aft) cross tube and left side of C241-4 (forward) cross tube as shown. Drill one 0.128 inch diameter hole in each cross tube and deburr. Clean up debris.
