R44

SERVICE LETTER #1

DATE: 24 May 1994
TO: All R44 Owners and Operators
SUBJECT: Adjustment of main rotor spindle boot and fluid level
ROTORCRAFT AFFECTED: R44 Helicopter S/N's 0006 thru 0070

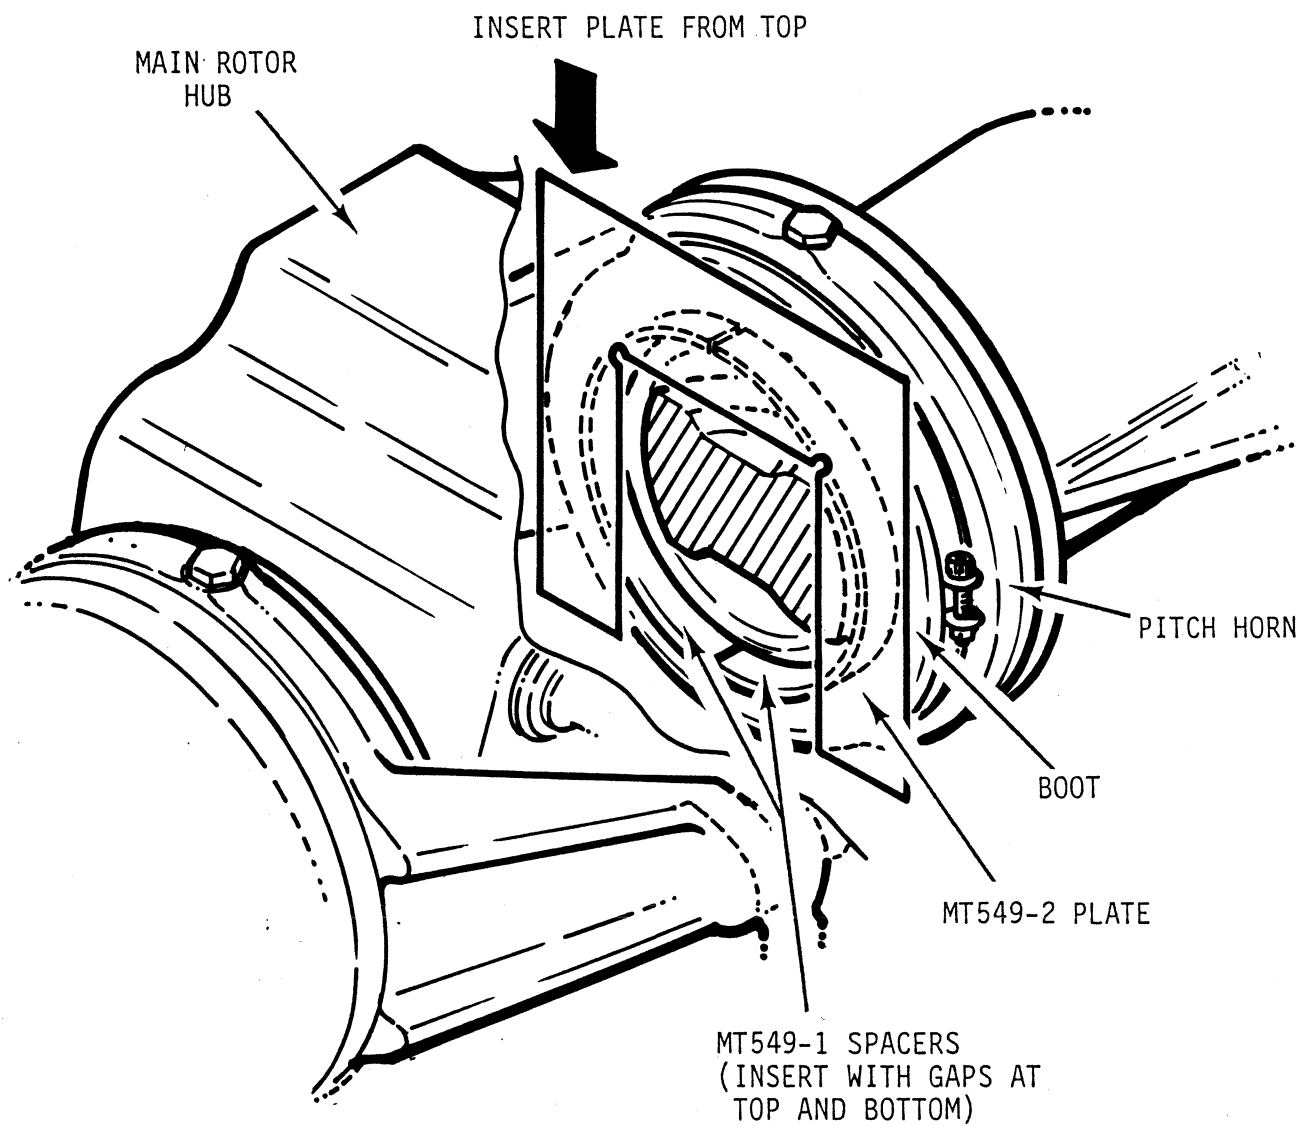
BACKGROUND: RHC has received reports concerning rubbing between the main rotor blade spindle boots and the main rotor hub. Continued rubbing could result in perforation of the boot and subsequent loss of the spindle bearings' lubricant. To prevent rubbing, a tool has been developed to allow adjustment of the fluid content with the blades installed on the helicopter.

- 1) Procure MT549-1 and MT549-2 tools from RHC Customer Service.
- 2) Position cyclic and collective at approximately mid-travel positions to minimize wrinkles in boots.
- 3) Insert two (2) MT549-1 spacers between hub and boot with gaps at top and bottom (refer to figure on page 2). Spacers should fit in recess of boot.
- 4) Hold spacers in place against boot and insert MT549-2 plate from top between hub and spacers while a second person removes the lower plug from the pitch horn. Place a finger over the hole as soon as the plug is removed to prevent air from being sucked inside the blade.
- 5) Reduce finger pressure on hole and allow oil to escape as plate is pushed fully down.
- 6) Remove finger from hole and quickly install drain plug. Torque to 60-80 in-lbs (includes self-locking torque).
- 7) Remove plate and spacers.
- 8) Repeat on second blade.
