R44

SERVICE LETTER SL-31

SUBJECT: Main Rotor Blade Inspection

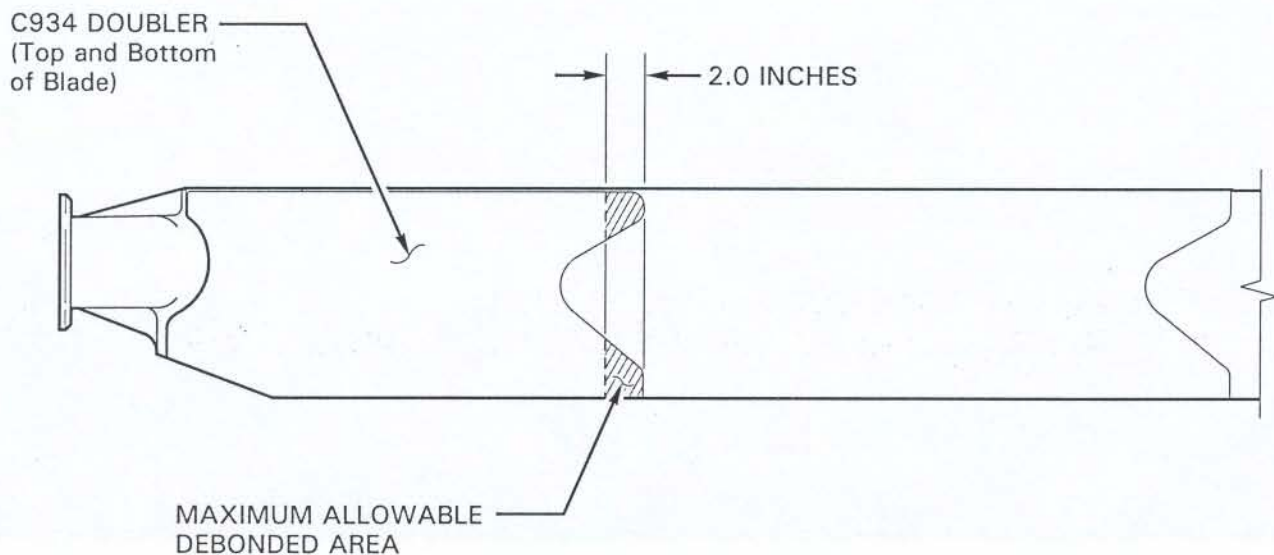
BACKGROUND: RHC has received reports of debonding at the tips of C934 doublers on C016-2 and -5 main rotor blades. While not an immediate airworthiness issue, inspection every 100 hours is warranted.

C016-2 & -5 MAIN ROTOR BLADE DEBOND LIMITS

1. During each 100-hour inspection, tap test outboard tips of C934 doublers (top and bottom of blade) as indicated in figure below.
2. If debond area exceeds limits, remove rotor blade from service and inform RHC Technical Support of blade serial number and time in service.
