**R66 SERVICE BULLETIN SB-07**

**SUBJECT:** Throttle Control Routing

**ROTORCRAFT AFFECTED:** R66 helicopters S/N 0004 thru 0394 except 0097, 0169, 0174, 0187, 0199, 0233, 0258, 0265, 0266, 0267, 0276, 0279, 0280, 0283, 0284, 0287, 0288, 0291, 0292, 0293, 0295, 0296, 0311, 0312, 0317, 0325, 0326, 0342, 0343, 0347, 0350 thru 0357, 0367, 0368, 0372, 0373, 0374, 0378, 0380, 0388, 0391, 0392, & 0393.

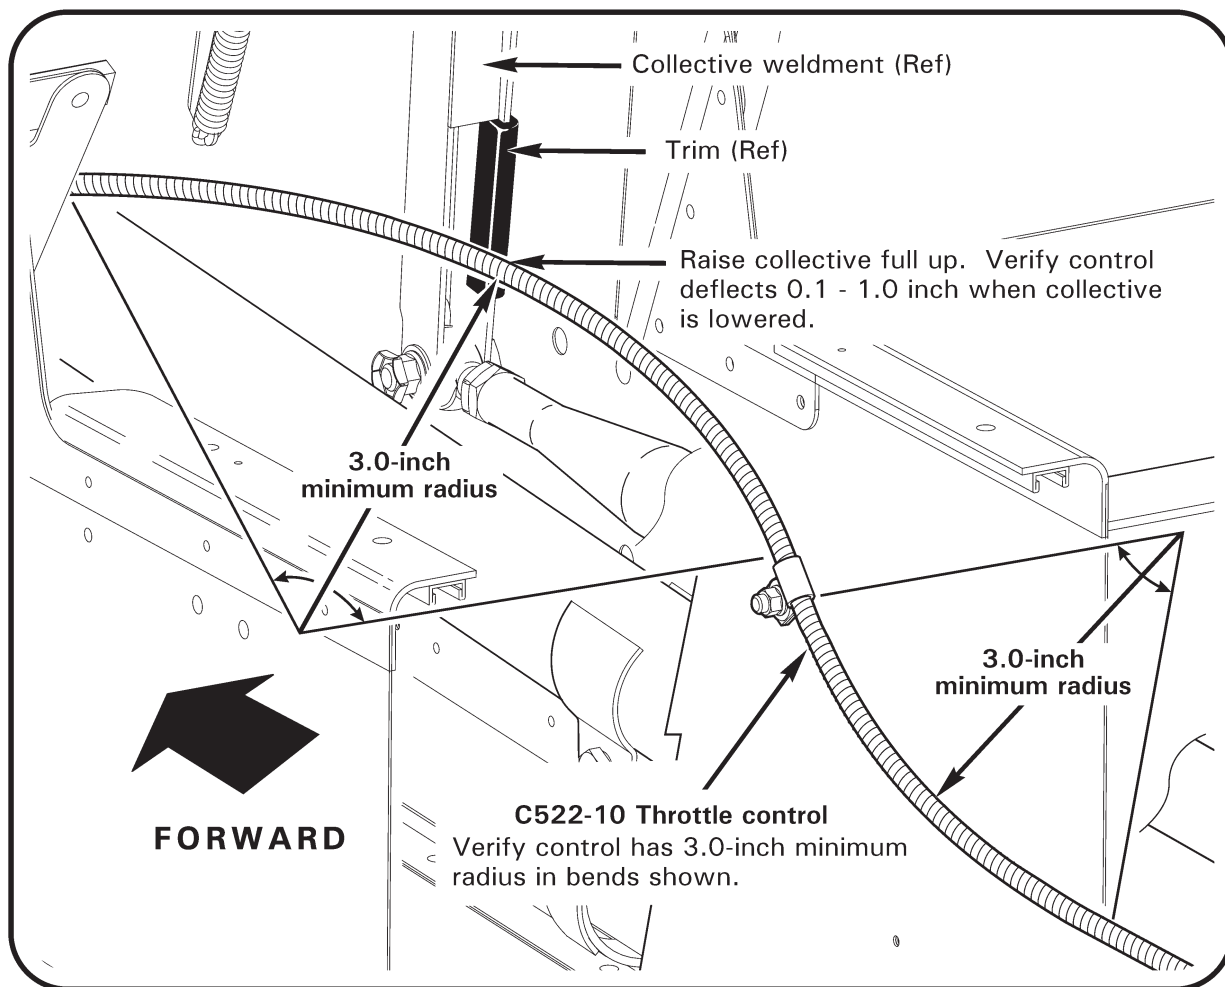
**FIGURE 2: View of C522-10 Throttle control in mid tunnel.**

**BACKGROUND:** RHC has received a report of a broken C522-10 control's inner wire, causing a loss of throttle control. The control wire broke near a mounting clamp where the control was routed with a sharp bend. This bulletin requires verifying the control is not damaged and that control bends have a minimum radius.

3. Refer to Figure 2. Using maintenance aid, verify C522-10 control has 3.0-inch minimum radius in bends shown. If required, loosen hardware securing adjacent clamps and adjust housing position in clamps. Tighten hardware and repeat step until bend radii are within limit.

4. If control routing was adjusted in previous step, due to a sharp bend, replace control's inner wire (P/N SSW-050-C522-10) and rig throttle control per MM § 76-11.

5. Raise collective full up. Verify control deflects 0.1-1.0 inch at trim on weldment when collective is lowered. If required, loosen hardware securing adjacent clamps and adjust housing position in clamps. Tighten hardware and repeat step until deflection is within limit. Maintain 3.0-inch minimum radius with collective up and down.
