**R66 SERVICE BULLETIN SB-09**

**SUBJECT:** Rotor RPM Sender Magnets

**ROTORCRAFT AFFECTED:** R66 helicopters S/N 0004 thru 0414, spare F006-1 main rotor gearbox assemblies, spare F908-1 yoke assemblies, and spare 102MG11 magnets. B570-1 magnets with black epoxy fillet are unaffected (see Figure 1).

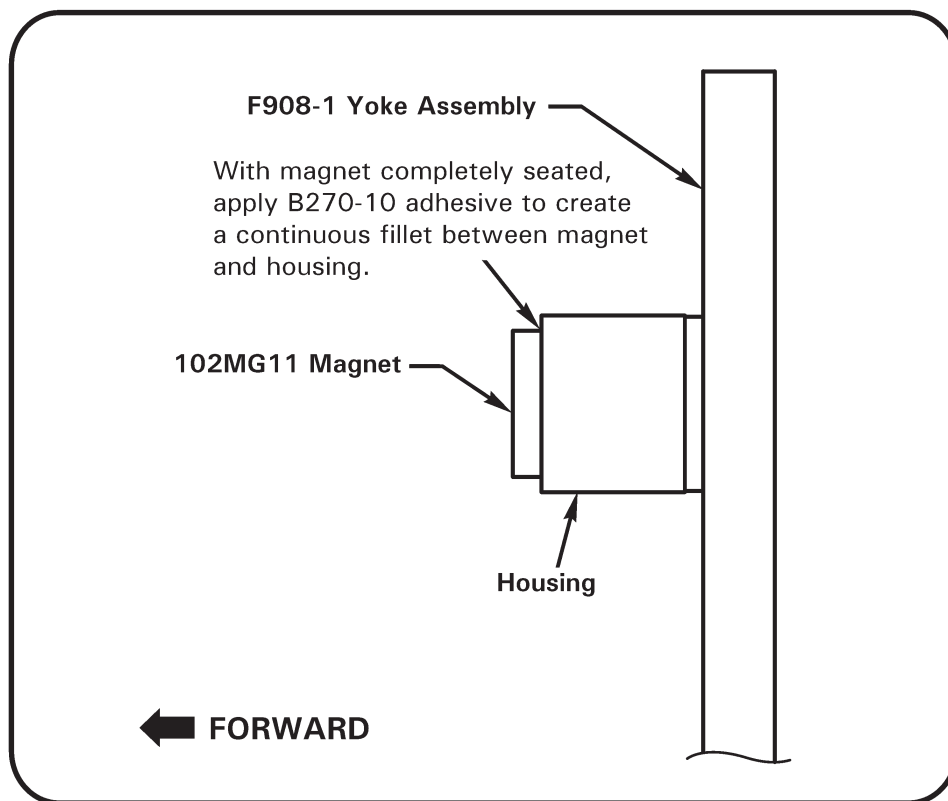
**FIGURE 3**

**BACKGROUND:** RHC received a report that a MRGB yoke assembly's 102MG11 magnet came out of its housing during flight and activated the low-rotor RPM warning system. This bulletin requires applying additional adhesive to affected magnets.

2. If gearbox is installed, remove tailcone cowling per R66 Maintenance Manual (MM) § 53-23.
3. Refer to Figure 3. Rotate blades as necessary. Press in on magnet with finger to ensure magnet is completely seated in magnet housing. Apply B270-10 adhesive to create a continuous fillet between magnet and magnet housing. Repeat for second magnet.
