R66 SERVICE BULLETIN SB-11

SUBJECT: Tail Gearbox Sight Gage

ROTORCRAFT AFFECTED: R66 helicopters S/N 0002 thru 0541, 0547, and 0551.

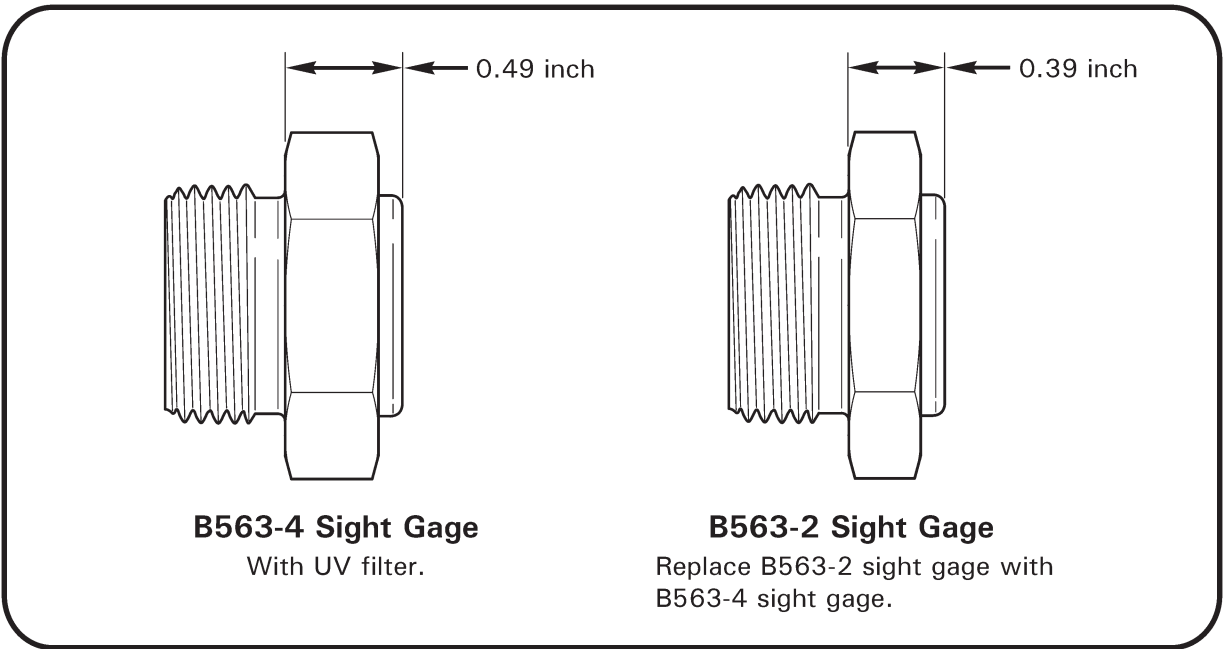
FIGURE 1

BACKGROUND: RHC has received reports of A257-22 oil staining the tail gearbox sight gage glass after exposure to direct sunlight. Stained glass can result in a false level indication. This bulletin requires replacing earlier gages with a B563-4 sight gage which incorporates an ultraviolet (UV) light filter which prevents staining due to sunlight.

1. Refer to Figure 1. If B563-4 sight gage (with UV filter) is installed, the requirements of this bulletin have been complied with. Proceed to step 5.
2. If B563-2 sight gage is installed, order one B563-4 sight gage and one A215-020 o-ring.
3. Remove sight gage per R66 Maintenance Manual (MM) § 12-22 Part A.
4. Apply A257-22 oil to new A215-020 o-ring and install on B563-4 sight gage. Install B563-4 sight gage per MM § 12-22 Part C.
5. Make appropriate maintenance record entries.
