**R66 SERVICE LETTER SL-06**

**SUBJECT:** Damper Assembly

**ROTORCRAFT AFFECTED:** R66 helicopters S/N 0003 thru 0197.

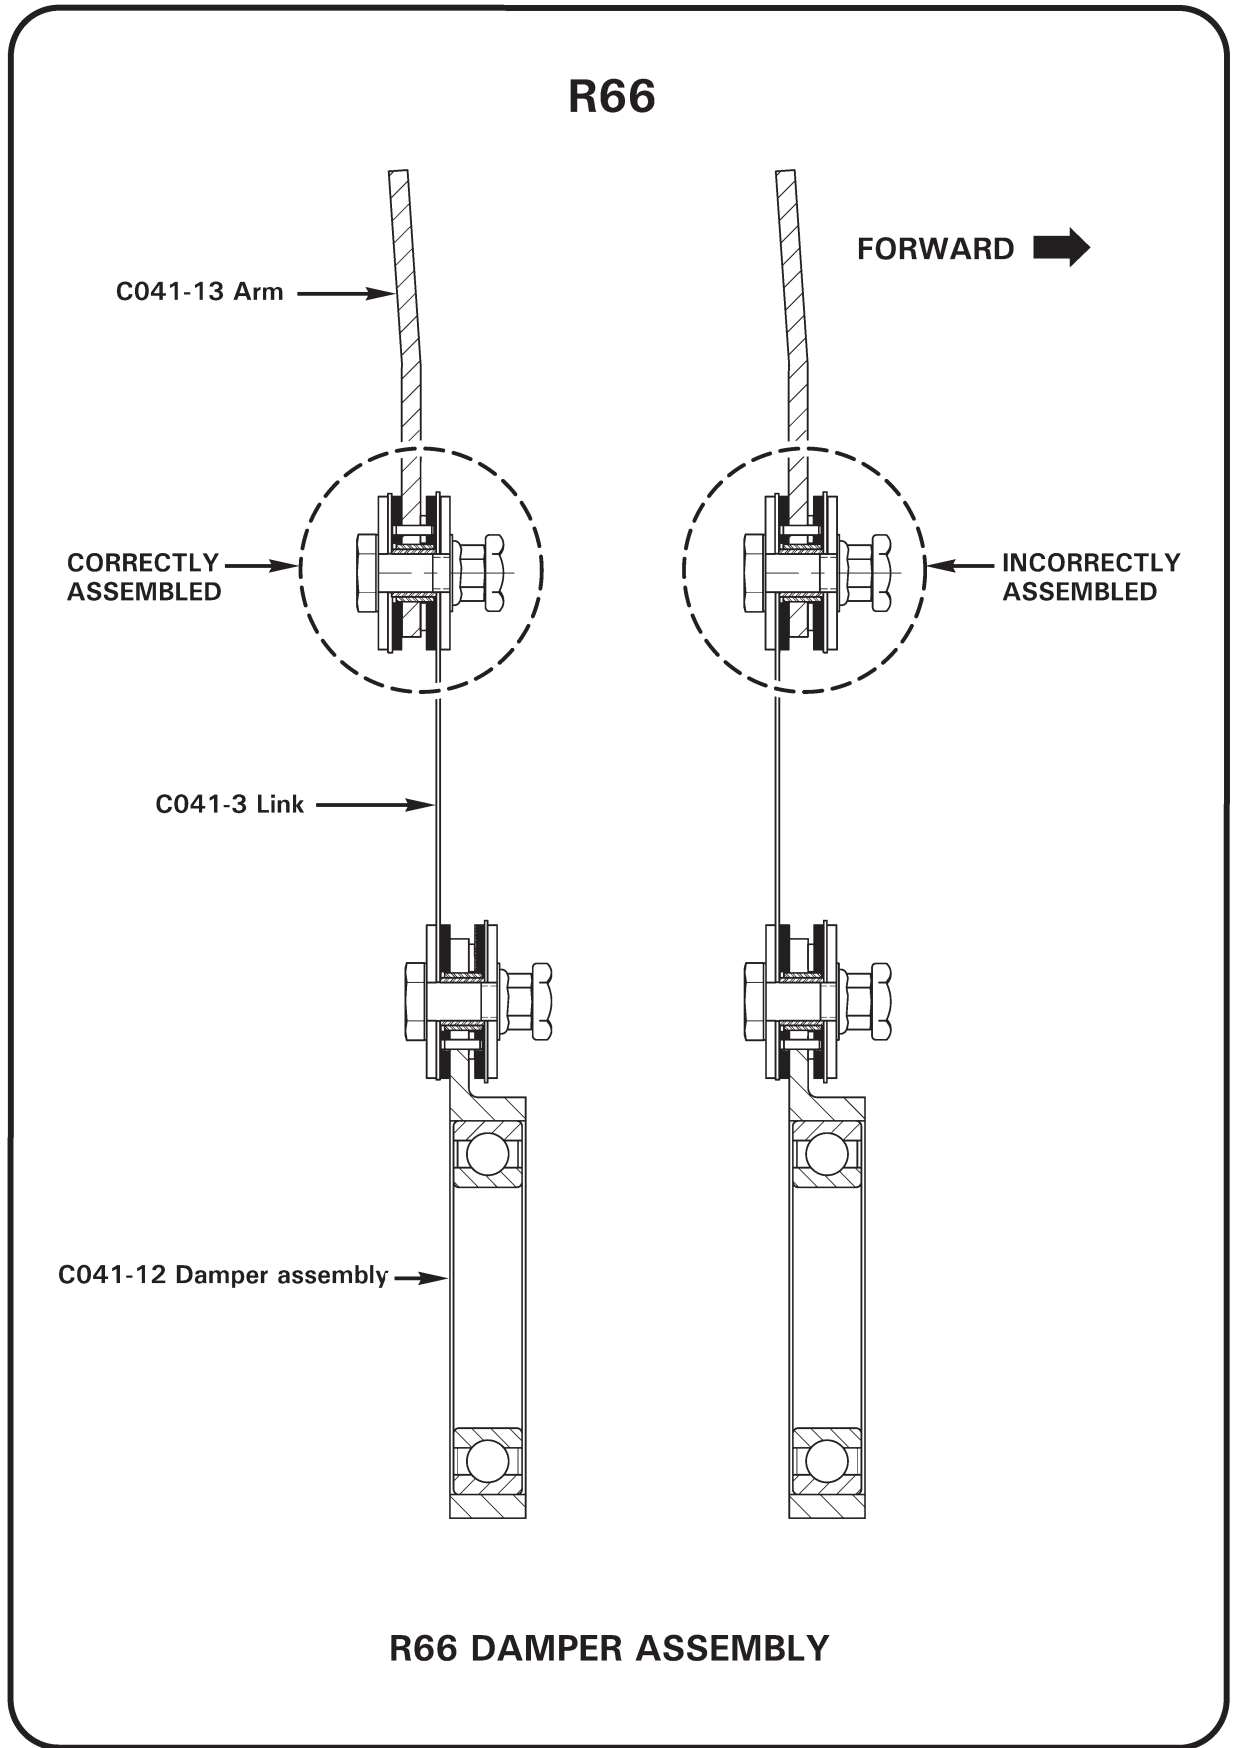
FIGURE 1

**BACKGROUND:** Some tail rotor drive shaft damper assemblies were assembled incorrectly during production. RHC recommends correcting affected dampers at next tail rotor drive shaft removal and installation.

1. Remove tailcone assembly's forward A231-1 inspection plug.
2. Refer to Figure 1. If C041-12 damper assembly's C041-3 link is installed forward of C041-13 arm, reinstall inspection plug; no further action is requested.
3. If damper's C041-3 link is installed aft of C041-13 arm, reinstall inspection plug and remove tail rotor drive shaft assembly per R66 Maintenance Manual (MM) § 65-20.
4. Disassemble, inspect, and correctly assemble damper per MM § 65-22.
5. Install tail rotor drive shaft assembly per MM § 65-20.
6. Make appropriate maintenance record entries.
