R66 SERVICE BULLETIN SB-16

SUBJECT: "LOT 20" F642-1 Shaft Corrosion

ROTORCRAFT AFFECTED: R66 Helicopters S/N 0143 thru 0172.

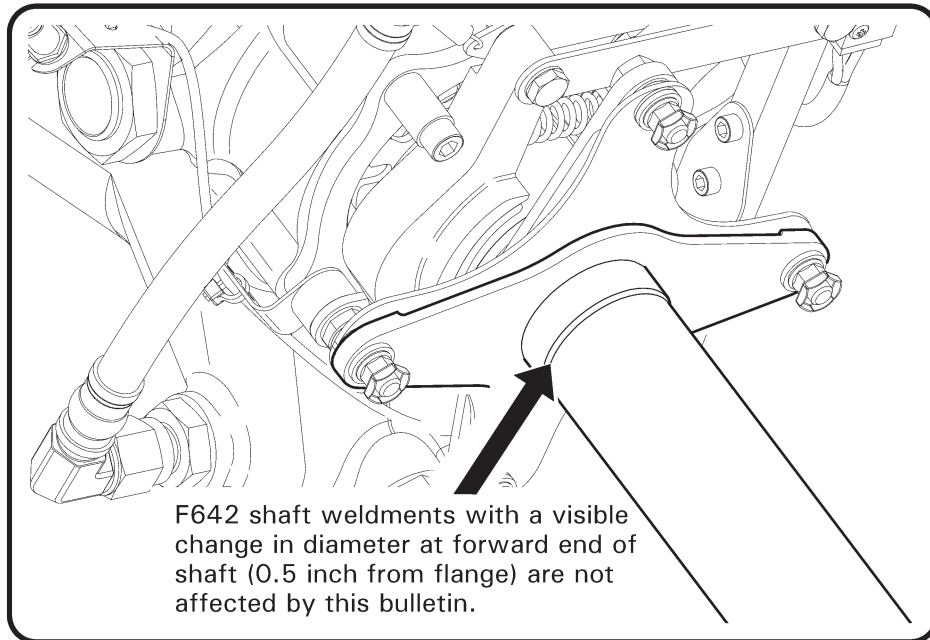
FIGURE 1

BACKGROUND: A "LOT 20" F642-1 shaft weldment failed due to internal corrosion. This bulletin requires a specific lot number (LOT 20) of earlier F642-1 shafts to be upgraded to (current design) F642-6 shaft weldments, which have additional corrosion protection.

1. Refer to Figure 1. Visually inspect forward end of installed F642 shaft weldment for a visible change in diameter. Shafts with a change in diameter at location shown are not affected by this bulletin; no further action is required.
2. If installed shaft does not have a change in diameter at location shown, locate ink-marked lot number on F642-1 shaft (adjacent to ink-marked part number and revision letter). Ink-mark may be located on shaft or flanges (disassembly from flex plates may be required; refer to R66 Maintenance Manual [MM] § 63-10).
3. If shaft is marked "LOT 20", or if the lot number cannot be determined, remove shaft per MM § 63-10, order one R9535 kit from [RHC Customer Service](#), and install kit per MM § 63-10.
4. Make appropriate maintenance record entries. No change to helicopter weight and balance.
