R66 SERVICE BULLETIN SB-18A

SUBJECT: MRGB Output Yoke Retaining Plug

ROTORCRAFT AFFECTED: R66 Helicopters S/N 0004 thru 0707.

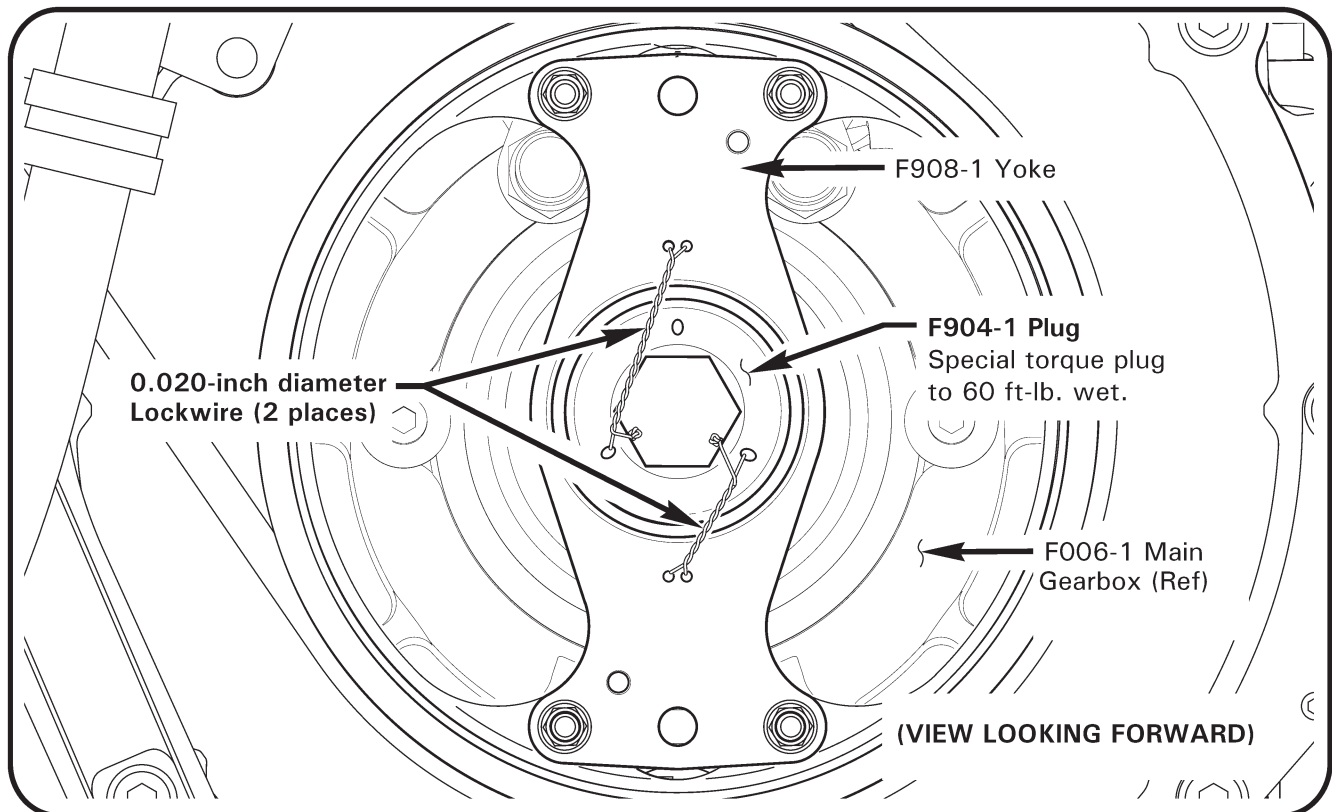
FIGURE 1

BACKGROUND: RHC has received an additional report of a loose F904-1 plug, which secures the F908-1 yoke to the main gearbox. The loosened plug caused the fanwheel to move aft and contact the scroll, followed by fanwheel failure. The yoke experiences higher loads on helicopters with air conditioning due to belt tension which may cause the plug to loosen. This bulletin requires increasing the plug torque and installing additional lockwire. SB-18A has reduced the compliance time due to the additional report.

6. In two places, install 0.020-inch diameter lockwire and safety plug to yoke with pigtails inside recess of plug as shown.
7. Install forward C947-3 flex plate assembly, using hardware removed (replace palnuts). Standard torque hardware per MM § 20-32 and torque stripe per MM Figure 5-1. Ensure safety wire is not contacting flex plate.
8. Install and shim intermediate C947-3 flex plate assembly per MM § 65-30.
9. Install hardware securing aft F305-5 inlet to scroll assembly. Verify 0.10 inch minimum gap between fanwheel assembly and inlet.
10. Install tailcone cowling per MM § 53-23.
11. Make appropriate maintenance record entries. No change to helicopter weight and balance.
