## **R22 SERVICE LETTER SL-72**

**SUBJECT:** New A020-90 & A047-6 Upper Frame Installation

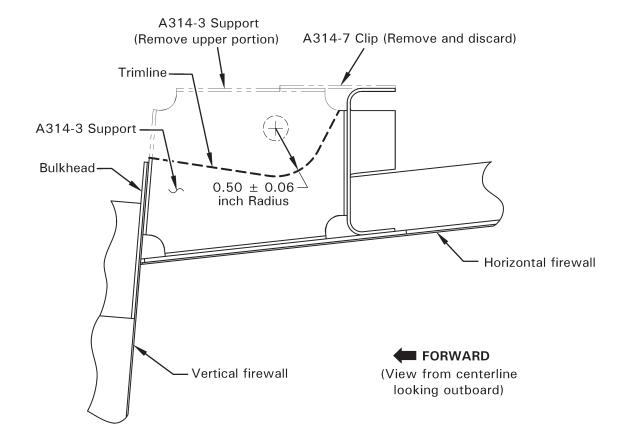
**BACKGROUND:** A020-2 and A047-1 upper frames have been superseded by A020-90 and A047-6 upper frames, which feature an integral inboard support for the A316-1 bellcrank. Approved alteration of existing A314-3 support is required when replacing superseded upper frames.

When replacing A020-2 or A047-1 upper frame with A020-9 or A047-6 upper frame, remove and discard A314-7 clip & attaching rivets, and trim upper portion of A314-3 support as shown. Smooth reworked edges and coat bare metal with primer.
