**R44 SERVICE BULLETIN SB-92A**  
(supersedes R44 SB-92)

**SUBJECT:** Tail Rotor Drive Shaft Damper Bearing

**ROTORCRAFT AFFECTED:** R44 Helicopters S/N 0006 thru 2449 and R44 II Helicopters S/N 10001 thru 14026. Spare D224-1 and D224-2 tail rotor drive shaft assemblies are also affected.

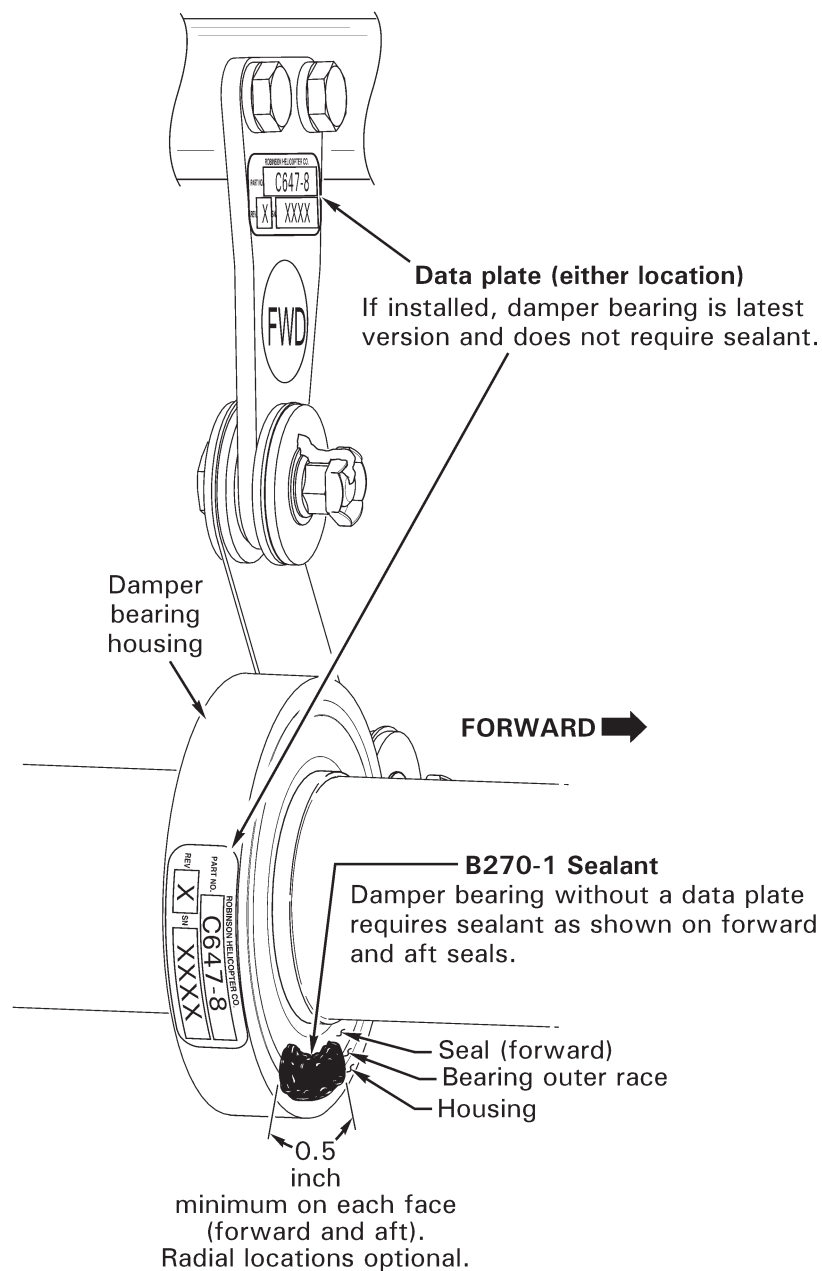
**FIGURE 1**

Refer to Figure 1. If a data plate is installed on the C041-8 arm or damper bearing housing, then the damper bearing is latest version and no sealant is required. A damper bearing without a data plate requires sealant per the following:
