R44 SERVICE BULLETIN SB-92

SUBJECT: Tail Rotor Drive Shaft Damper Bearing

ROTORCRAFT AFFECTED: R44 Helicopters S/N 0006 thru 2449 and R44 II Helicopters S/N 10001 thru 14026.

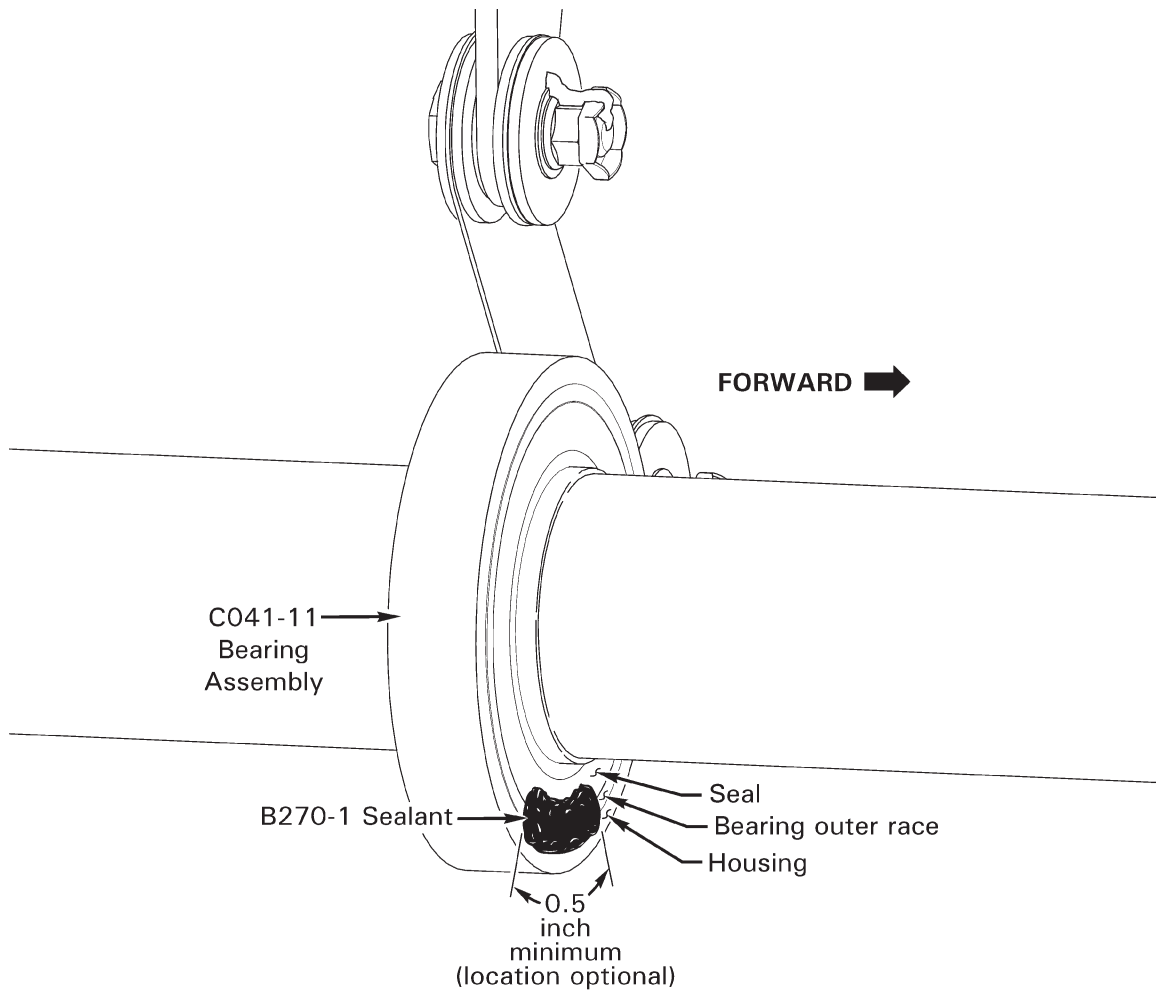
FIGURE 1

BACKGROUND: RHC has received reports of tail rotor drive shaft damper bearing seals rotating. A rotating seal may lead to loss of lubricant. This bulletin requires applying B270-1 sealant to seals of damper bearing (2 places) to prevent seal rotation.

2. Refer to Figure 1. Visually inspect forward and aft sides of damper bearing (refer to R44 Illustrated Parts Catalog Figure 65-5) and verify minimum 0.5 inch length of B270-1 sealant anywhere along junction of black seal and bearing outer race.

3. As applicable, clean accessible portion of seals lacking sealant with cotton swabs dampened with acetone. Using a smooth, rounded tool of sufficient length, apply a minimum 0.5 inch long bead of B270-1 sealant at most accessible junction of seal and bearing outer race; sealant contact with housing is permissible. Allow sealant to cure.
