R22 SERVICE LETTER SL-79

R44 SERVICE LETTER SL-65

DATE: 08 June 2018

SUBJECT: Unauthorized Repairs on Main Rotor Blades in Brazil

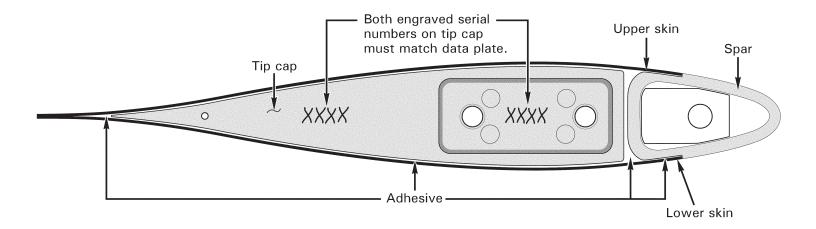
FIGURE 1

BACKGROUND: RHC has received reports and allegations from Brazil of unauthorized repairs to A016-4 (R22), C016-2 (R44), and C016-5 (R44 II) main rotor blades. During these unauthorized repairs, debonded blade skins were reglued at blade tip using unapproved materials. Repairs to debonded blade skins are not authorized by any RHC Maintenance Manual. In some cases, the blade data plate was altered; in all cases the unauthorized repairs were undocumented. **Unauthorized repairs to rotor blades have caused fatal crashes.**

- 1. Refer to Figure 1. Remove both MR blade tip covers. On each MR blade, verify the serial number is the same in the following locations:
 - a. Stamped on data plate on inboard lower skin (not shown).
 - b. Engraved on blade tip aft of tip weight recess (may require paint removal per step 5).
 - c. Engraved on blade tip between tip weight nutplates. (May require tip weight removal. If removed, install same weight[s] and special torque screws to 40 in.-lb wet with A257-9 anti-seize.)

- Inspect blade tips per the following:
 - a. Refer to Figure 1. Using 10X magnification, visually inspect adhesive surrounding tip cap; adhesive must be same light-brown color at all locations and without voids.

MAIN ROTOR BLADE TIP ADHESIVE AND SERIAL NUMBER LOCATIONS

Remove blade from service if serial number is not the same in the above locations, or if data plate is missing, or if any serial number is illegible.

- Using a sanding block with 320-grit aluminum-oxide abrasive paper, remove paint from blade tip outboard vertical surface by hand-sanding only in a chordwise direction to expose bare metal; do not remove serial number engraved on blade tip. Refer to Figure 1.

Remove blade from service if adhesive is not light-brown color, or if a void is visually or audibly detected.

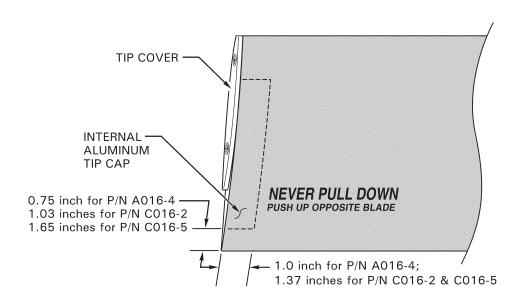
FIGURE 2

- b. Refer to Figure 2. Using an AN970-4 washer, tap test skin-to-tip cap bond joints on both upper and lower surfaces for separation or voids (which cause a dull, non-metallic sound).

MAIN ROTOR TIP CAP DIMENSIONS
(View looking up)
