## **R44 SERVICE BULLETIN SB-96**

**DATE:** 02 October 2018

**SUBJECT:** D602-1 Time Delay Assembly

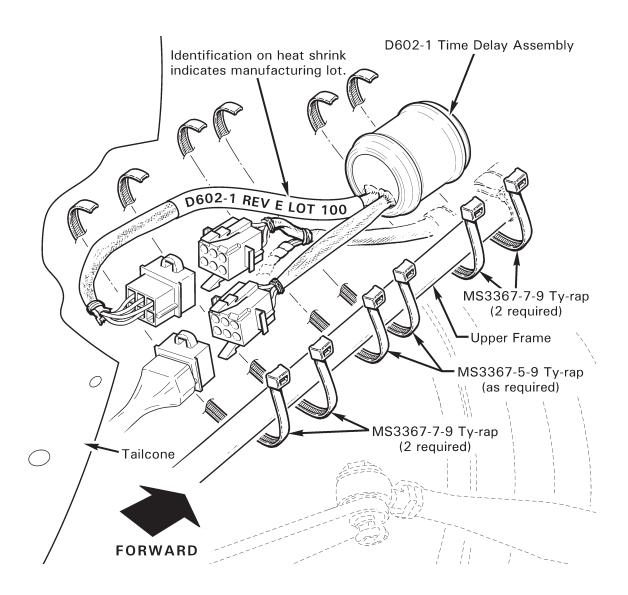
FIGURE 1

**BACKGROUND:** RHC has determined that Lot 99 and Lot 100 of D602-1 (Clutch Actuator) Time Delay Assemblies were assembled with an incorrect resistor, which may cause the circuit to overheat in service.

- For each affected helicopter, order a replacement D602-1 Time Delay Assembly from RHC Customer Service. Note that MS3367-5-9 and MS3367-7-9 ty-raps will also be required as shown in Figure 1.

- 2. Remove C706-1 tailcone cowling assembly.
- 3. Verify battery switch is off. Refer to Figure 1. Cut and discard ty-raps securing D602-1 Time Delay Assembly to frame. Disconnect time delay assembly from airframe harness and remove time delay assembly.

- 4. Connect replacement D602-1 Time Delay Assembly to airframe harness at connector. Secure with ty-raps as shown. Cinch ty-raps until snug without over-tightening, and trim tips flush with heads. Verify security.
