R66 SERVICE LETTER SL-28

DATE: 05 November 2018

SUBJECT: Main Rotor Gearbox Internal Visual Inspection

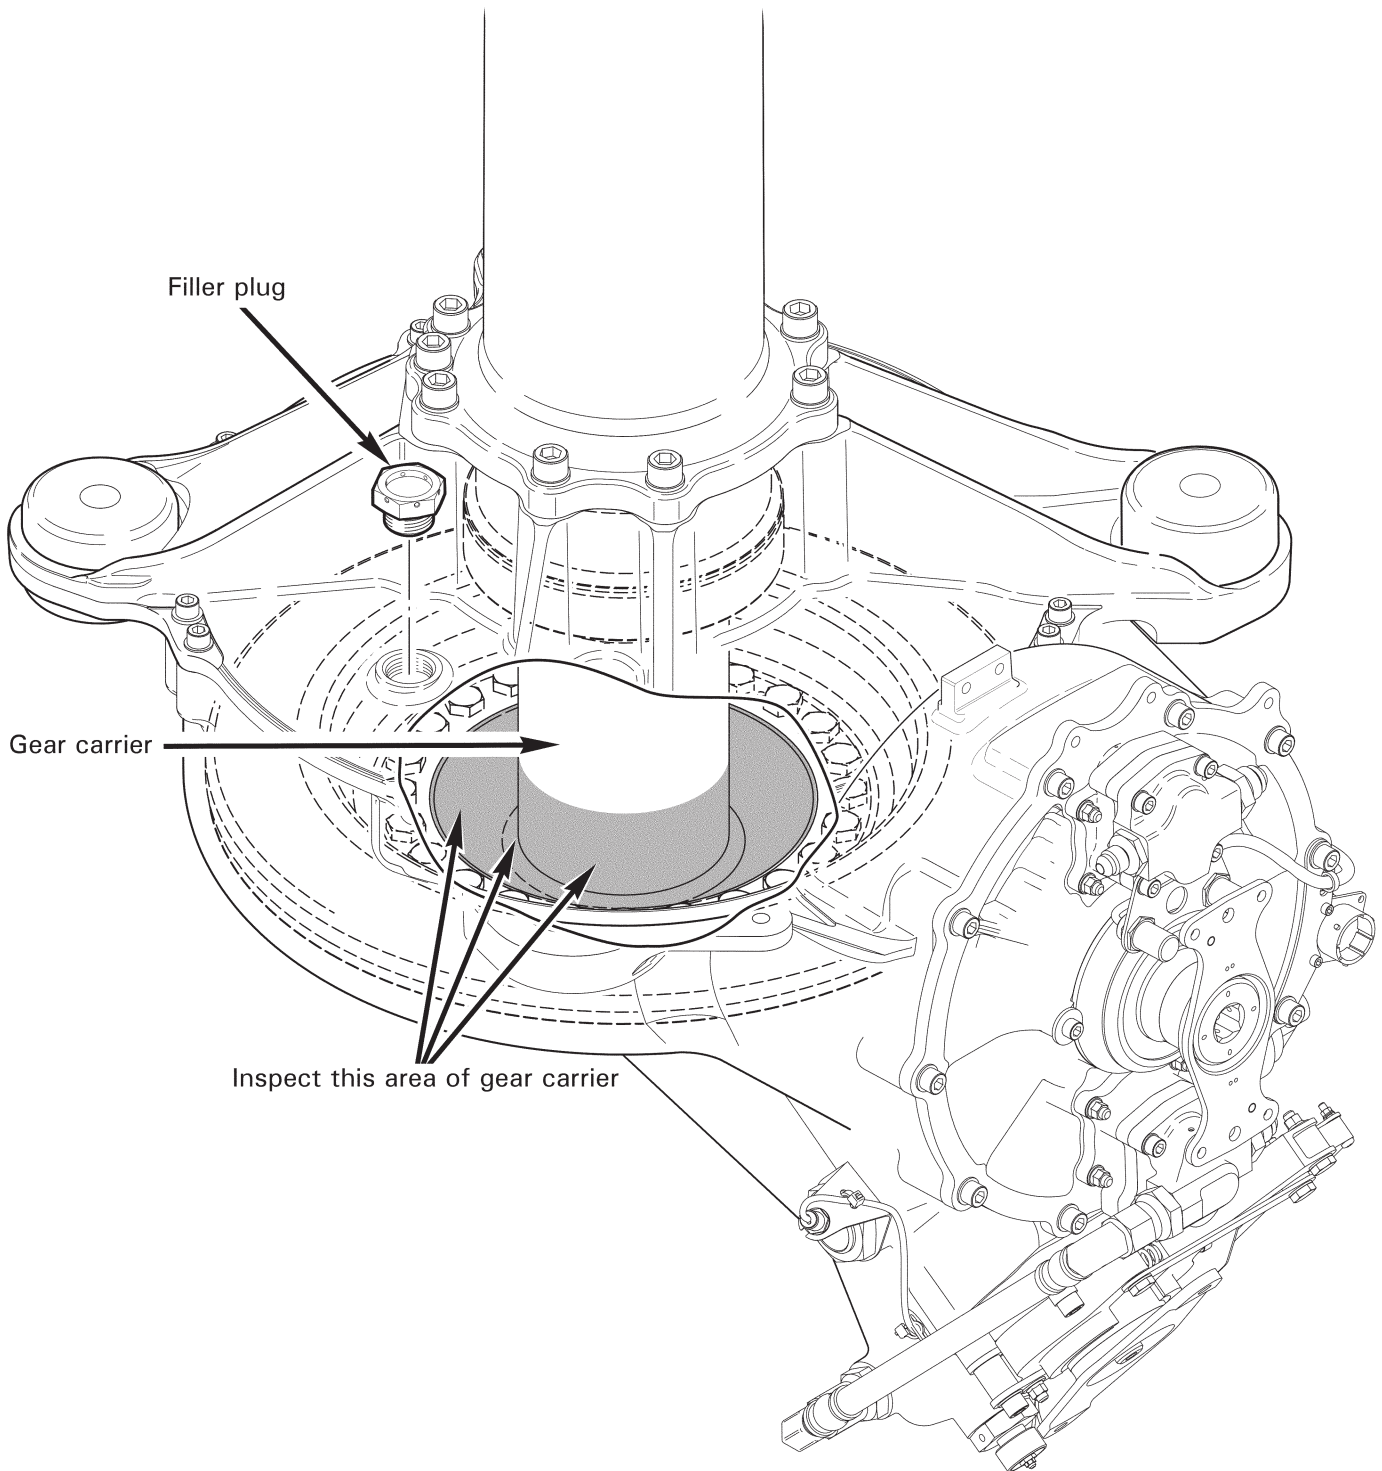
FIGURE 1

BACKGROUND: RHC recommends an internal visual inspection of the main rotor gearbox (MRGB) annually per the procedure below (may be coincident with aircraft annual inspection). Inspection is prompted by observations of internal corrosion beginning to form on some units returned to the factory for repair or overhaul. Corrosion is more likely on helicopters which are operated infrequently. Visual inspection will be included in R66 Maintenance Manual Table 1, Scheduled Inspections at the next revision.

1. Refer to Figure 1. Gain access to and remove MRGB filler plug.
2. Via filler plug hole and using borescope, miniature camera, or smartphone camera with flash, visually inspect specified area of gear carrier. Rotate gearbox by hand-turning main or tail rotor as required to view entire circumference.
3. If no corrosion is evident, install filler plug and special torque per MM § 20-33.
4. If corrosion is detected, contact [RHC Technical Support](#).
5. Make appropriate maintenance record entries.
