R22 SERVICE LETTER SL-82B

R44 SERVICE LETTER SL-68B

R66 SERVICE LETTER SL-26B

SUBJECT: Main Rotor Blade Tip Plate Permanent Removal

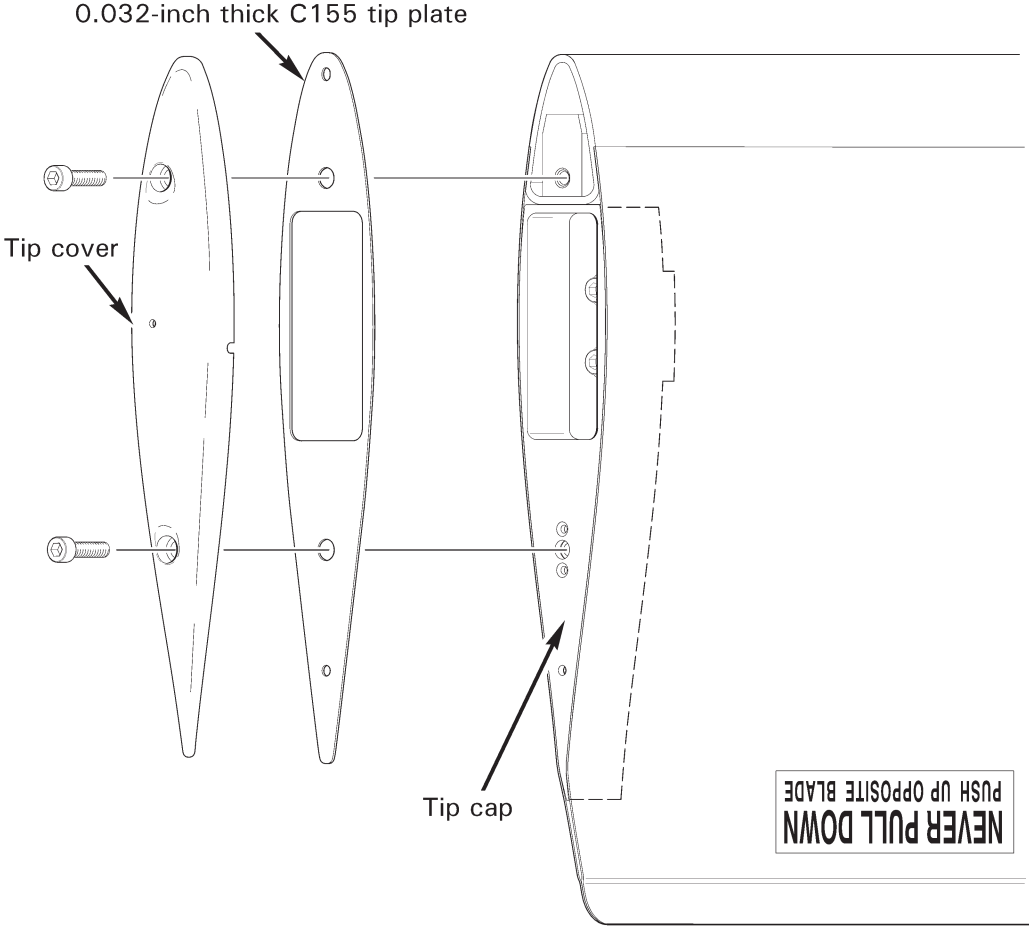
BACKGROUND: RHC recommends permanently removing C155 tip plates from A016-6, C016-7, & F016-2 main rotor blades to facilitate inspections and reduce chance of corrosion.

Refer to Figure on page 2. For each affected main rotor blade:

1. Position main rotor blade to allow tip access and apply rotor brake. Support blade in level (spanwise) position with cushioned stand.
2. Remove tip cover from blade.
3. Using razor blade held parallel with tip plate and mallet, initiate separation of tip plate from blade tip at leading edge. Peel off plate by pulling with pliers.
4. Comply with R22 SL-83 / R44 SL-70 / R66 SL-30. If tip plate was removed from only one blade, weigh removed tip plate and add equal amount balance weight to tip.
5. Make appropriate maintenance record entries.
