R44 SERVICE BULLETIN SB-110

DATE: 6 January 2022

SUBJECT: C029-3 Tail Rotor Blade Cracks

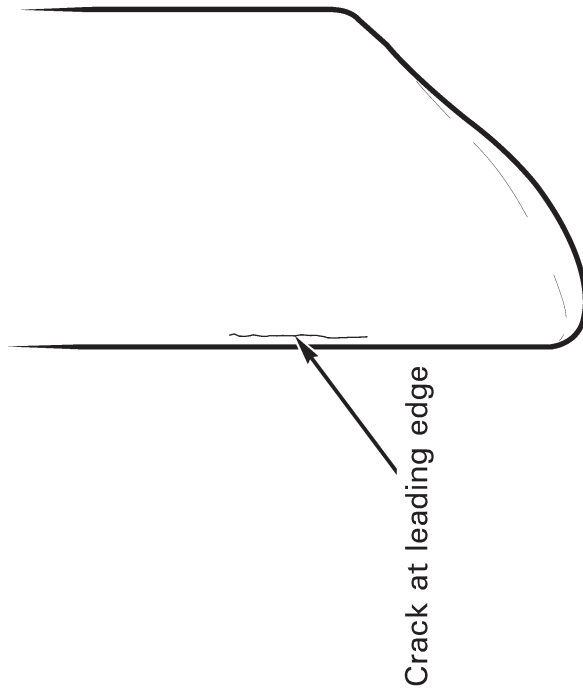
As part of each preflight inspection, perform detailed visual inspection of outboard 12 inches (30 cm) of blade leading edge. If any hairline crack similar to one shown in figure is found, aircraft is unairworthy. Replace blade prior to further flight.

Crack at leading edge
