R66 SERVICE BULLETIN SB-40

DATE: 6 January 2022

SUBJECT: F029-1 Tail Rotor Blade Cracks

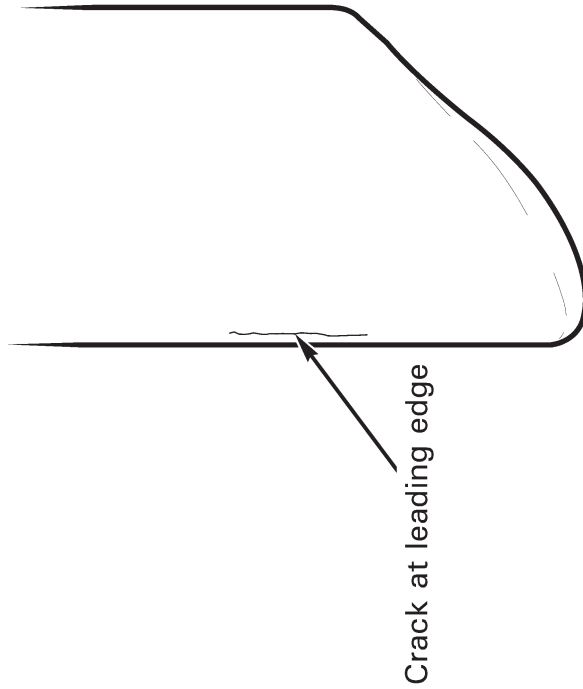
As part of each preflight inspection, perform detailed visual inspection of outboard 12 inches (30 cm) of blade leading edge. If any hairline crack similar to one shown in figure is found, aircraft is unairworthy. Replace blade prior to further flight.

Crack at leading edge
