R22 SERVICE BULLETIN SB-120

SUBJECT: Tail Rotor Blade Inspection and Replacement

EFFECTIVITY: P/N A029-2 tail rotor blade S/Ns 11279 and prior (A029-2 REV U and prior). Affected blades were factory-installed on R22 Helicopter S/Ns 4873 and prior.

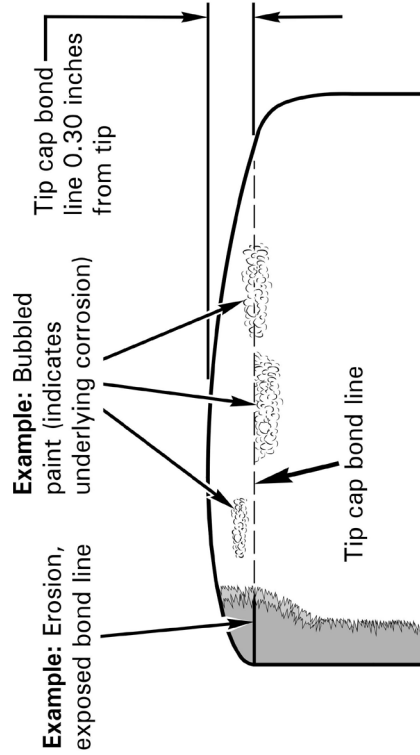
BACKGROUND: RHC has received reports of tail rotor blade tips coming loose due to corrosion at the bond. Helicopters operating near saltwater are particularly susceptible to corrosion, especially if stored outdoors. A debonded tip can cause severe vibration and possible failure of the tail rotor gearbox housing. A029-2 revision V blades have tip caps with an alternate alloy to reduce the likelihood of corrosion.

Refer to Figure below.

To be performed before the first flight of each day. May be performed by pilot or mechanic. Conduct visual inspection of tail rotor tip area. If bubbled paint or other evidence of corrosion is observed at or adjacent to tip cap bond line or if any portion of tip cap bond line is exposed, do not fly helicopter. Comply with latest revision of R22 SL-93 prior to further flight.

PART B: Replace each affected tail rotor blade per R22 Maintenance Manual (MM) § 28-20 and install tail rotor assembly per MM § 28-10. Enter new blade serial numbers in aircraft maintenance records.
