R44 SERVICE BULLETIN SB-112A
(supersedes R44 Service Bulletin SB-112)

DATE: 22 December 2022 **REV A:** 26 March 2024

SUBJECT: Tail Rotor Blade Inspection and Replacement

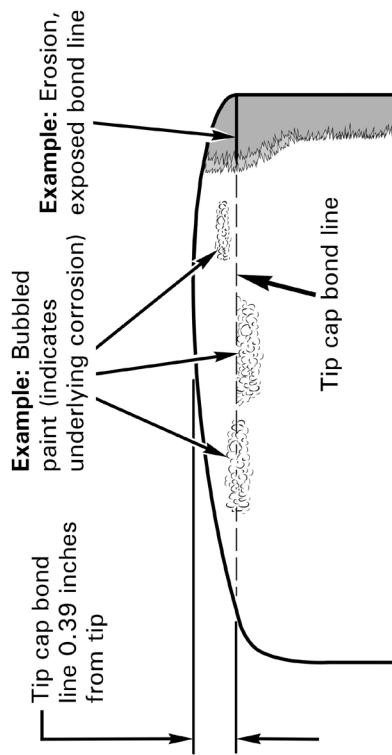
BACKGROUND: RHC has received additional reports of tail rotor blade tips coming loose due to corrosion at the bond. Helicopters operating near saltwater are particularly susceptible to corrosion, especially if stored outdoors. A debonded tip can cause severe vibration and possible failure of the tail rotor gearbox housing. C029-3 revision R blades have tip caps with an alternate alloy to reduce the likelihood of corrosion. Revision A of this bulletin shortens the time of compliance for tail rotor blade replacement (Part B Replacement) due to the additional reports.

To be performed before the first flight of each day. May be performed by pilot or mechanic. Conduct visual inspection of tail rotor tip area. If bubbled paint or other evidence of corrosion is observed at or adjacent to tip cap bond line or if any portion of tip cap bond line is exposed, do not fly helicopter. Comply with latest revision of R44 SL-82 prior to further flight.

Part B Replacement: No later than 31 July 2024.
Helicopters operated and/or stored outdoors in corrosive environments such as saltwater coastlines should replace affected blades as soon as practical.

PART B: Replace each affected tail rotor blade per R44 Maintenance Manual (MM) § 30-20 and install tail rotor assembly per MM § 30-10. Enter new blade serial numbers in aircraft maintenance records.
