R66 SERVICE BULLETIN SB-41A
(supersedes R66 Service Bulletin SB-41)

DATE: 22 December 2022 **REV A:** 26 March 2024

SUBJECT: Tail Rotor Blade Inspection and Replacement

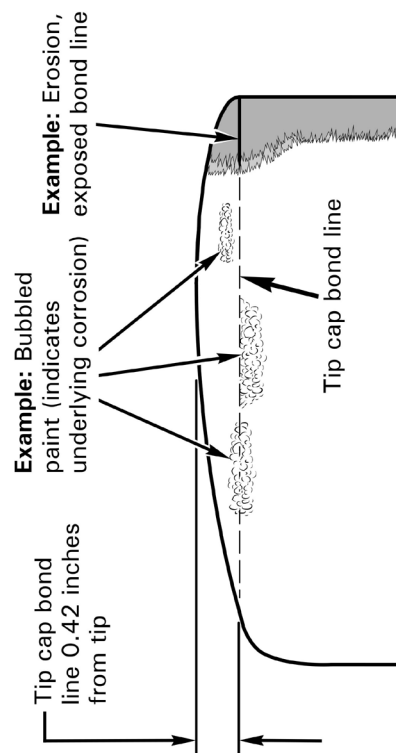
SPECIAL TAIL ROTOR TIP PREFLIGHT INSPECTION

BACKGROUND: RHC has received additional reports of tail rotor blade tips coming loose due to corrosion at the bond. Helicopters operating near saltwater are particularly susceptible to corrosion, especially if stored outdoors. A debonded tip can cause severe vibration and possible failure of the tail rotor gearbox housing. F029-1 revision I blades have tip caps with an alternate alloy to reduce the likelihood of corrosion. Revision A of this bulletin shortens the time of compliance for tail rotor blade replacement (Part B Replacement) due to the additional reports.

To be performed before the first flight of each day. May be performed by pilot or mechanic. Conduct visual inspection of tail rotor tip area. If bubbled paint or other evidence of corrosion is observed at or adjacent to tip cap bond line or if any portion of tip cap bond line is exposed, do not fly helicopter. Comply with latest revision of R66 SL-40 prior to further flight.

PART B: Replace each affected tail rotor blade per R66 Maintenance Manual (MM) § 64-20 and install tail rotor assembly per MM § 64-10. Enter new blade serial numbers in aircraft maintenance records.
