SERVICE BULLETIN #61

TO: All R22 Owners and Service Centers SUBJECT: Latches on Carburetor Air Box

ROTORCRAFT AFFECTED: R22 helicopters S/N 0885 thru 0948 and 0184,

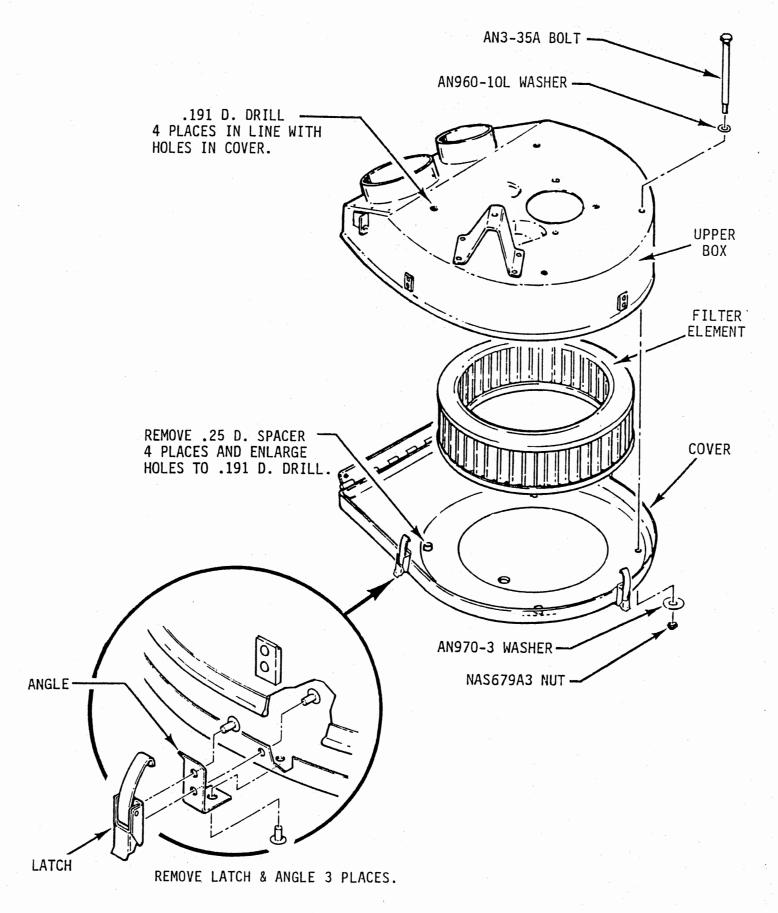
Several instances have been reported of the latches on the carburetor air box cover coming loose in flight allowing the air filter to become lost or dislodged. A dislodged air filter could partially block the carburetor—air inlet causing an inflight power loss and lead to a serious accident.

Refer to attached drawing.

- 1. Open air box and remove filter element.
- 2. Drill out four rivets in cover holding .25 D spacers and enlarge holes to .191 D drill. Discard spacers.
- 3. Close cover and using holes in cover as guides, drill four matching holes thru the upper box in line with the holes in the cover.
- 4. Open air box and drill out all rivets holding latches to cover. Discard latches and angles.
- 5. Install filter element and secure cover using four AN3-35A bolts, AN960-101 washers, AN970-3 washers, and NAS679A3 nuts.
